# Phillips 66 Fire & Explosion

Robert M. Bethea  
Texas Tech University

Houston Chemical Complex  
Pasadena Texas  
October 23, 1989

# Fire and Explosion in PE Reactor

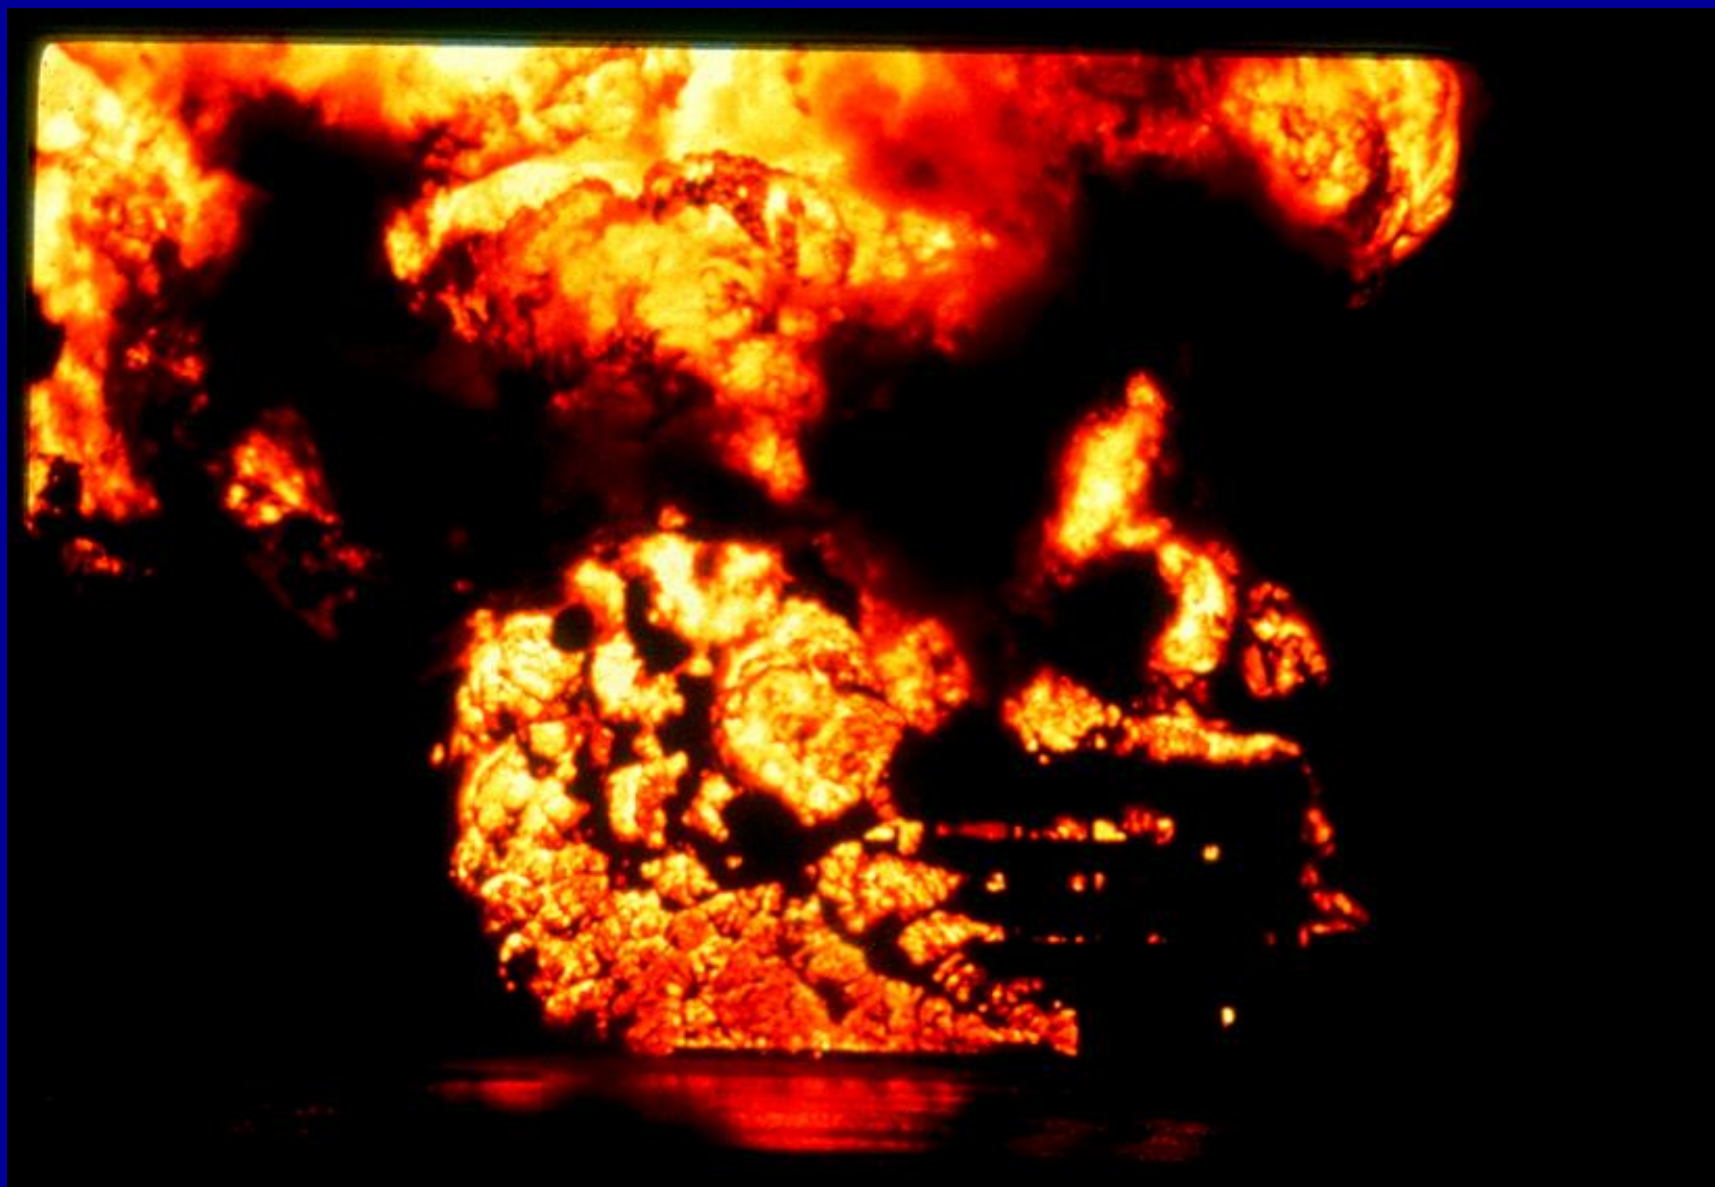
- Sudden gas release through open DEMCO valve – 85,000 lb<sub>m</sub> mixture of hydrogen, ethylene, hexene & isobutane
- Unidentified ignition source “found” within 2 min.
- Explosion equivalent to 2.4 tons of TNT
- Second explosion 10-15 min. later:  
2 isobutane storage tanks
- More explosions during next 2 hrs.

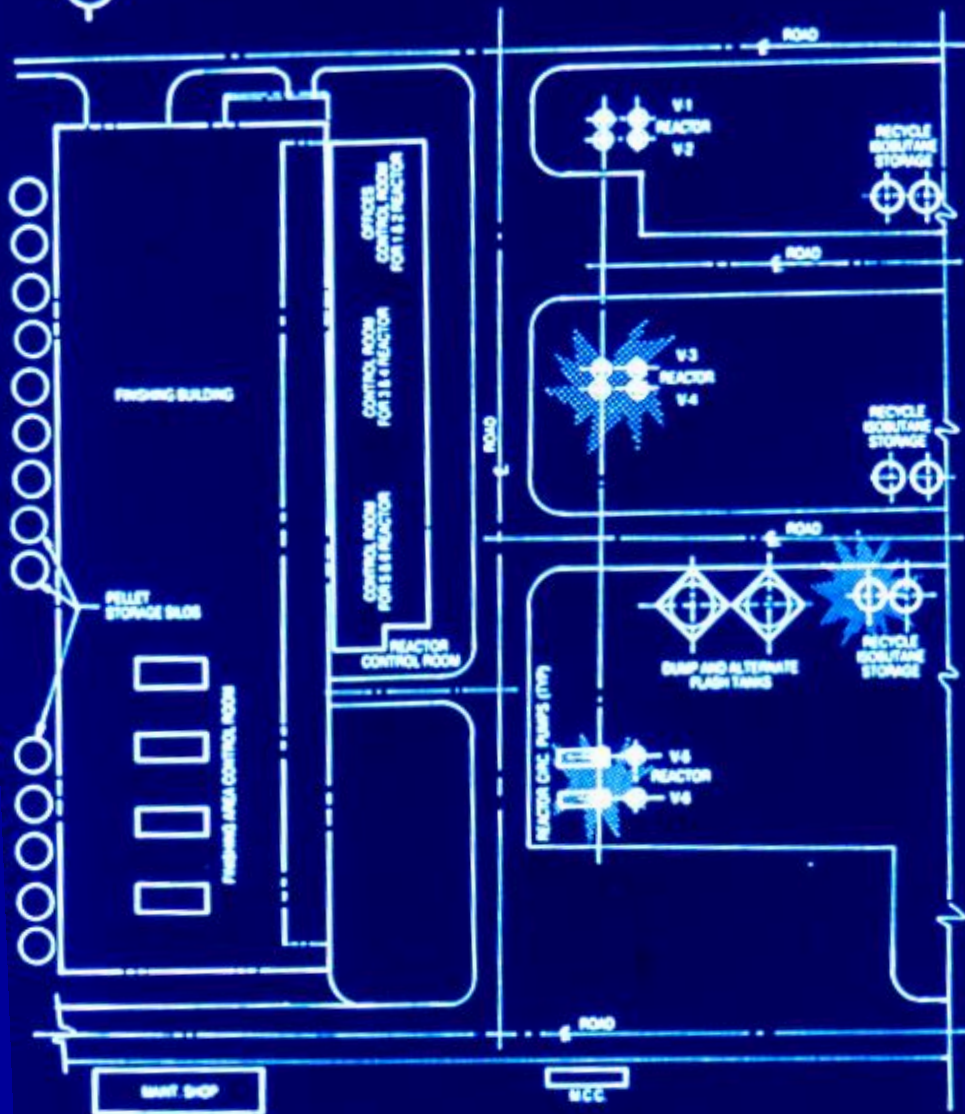
- 23 workers killed: 2 contractor, 21 Phillips
- Debris scattered over 6-mile radius
- 2 polyethylene plants completely destroyed
- Property damage: \$715 million (1/1/93)
- Business interruption loss: \$700 million (1/1/93)
- Disruption of plant fire-fighting water
- Only 1 effective diesel backup fire-water pump

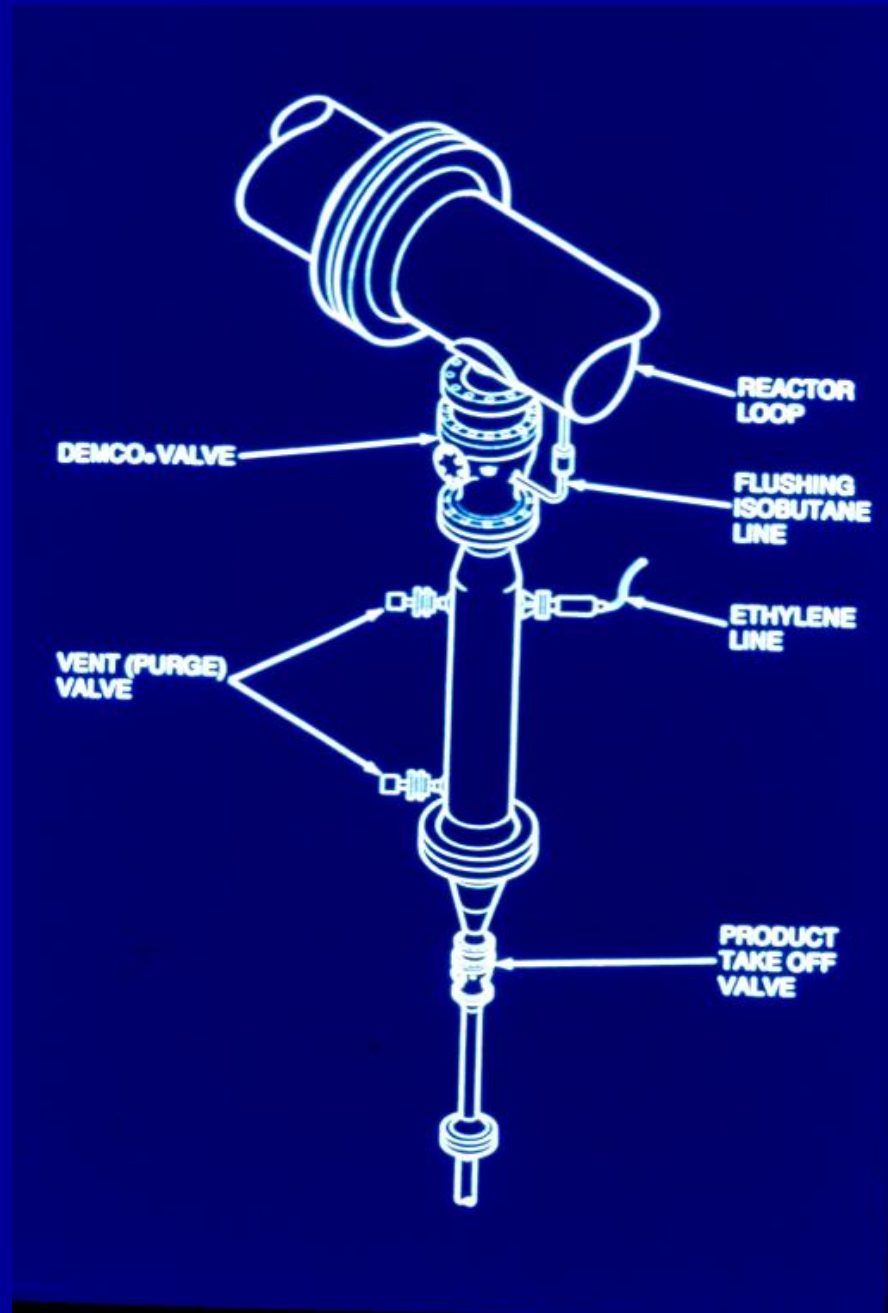
# Reactor Settling Leg

- 3 settling legs on Reactor 6 were plugged
- All legs prepared by Phillips operator:
  - ready for maintenance
  - DEMCO valve in closed position
  - air hoses disconnected
- Fish Engineering (maintenance contractor)
  - partially disassembled no. 4 leg
  - extracted polyethylene “log”
  - requested Phillips operator assistance

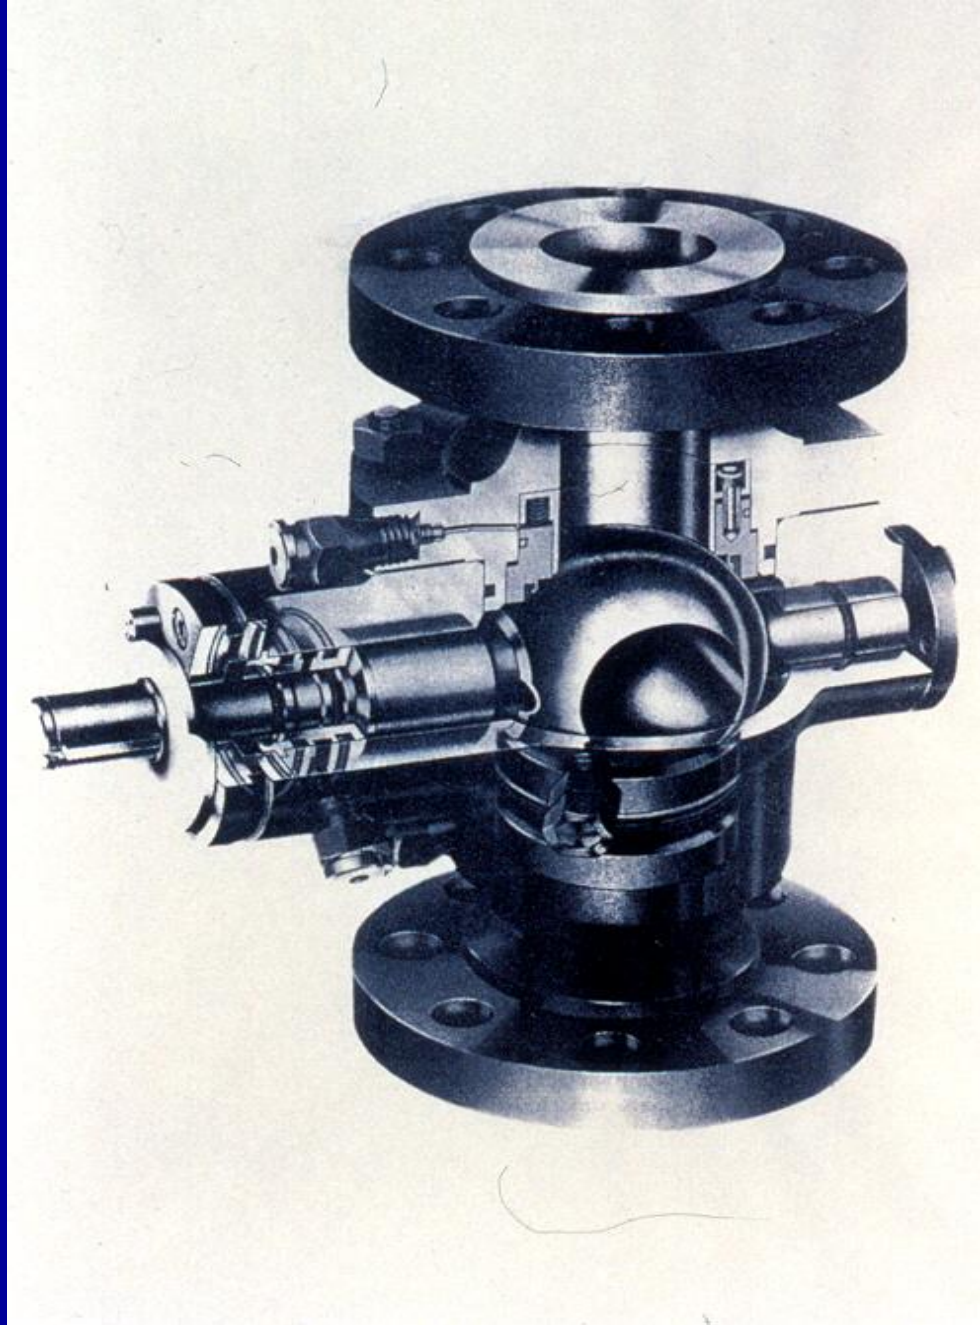
# Demco Valve

- DEMCO valve open at time of release
- Air hoses connected in reverse position
- Inadequate valve lockout system
- Local procedures did not incorporate required double block valves or blind flange insert when a line in a chemical or hydrocarbon service is opened

- No lockout device in place on DEMCO valve actuator mechanism
- Air supply hoses could be connected during maintenance
- Identical air hose connectors for “open” and “closed” sides of valve
- Air supply valves for actuator hoses in “open” position

- 2b. No provision for redundancy on DEMCO valves, no adequate lockout/tagout procedure, improper design of [DEMCO] valve actuator mechanism.
3. An effective safety permit system was not enforced with regard to Phillips or contractor employees to ensure proper safety precautions during maintenance.

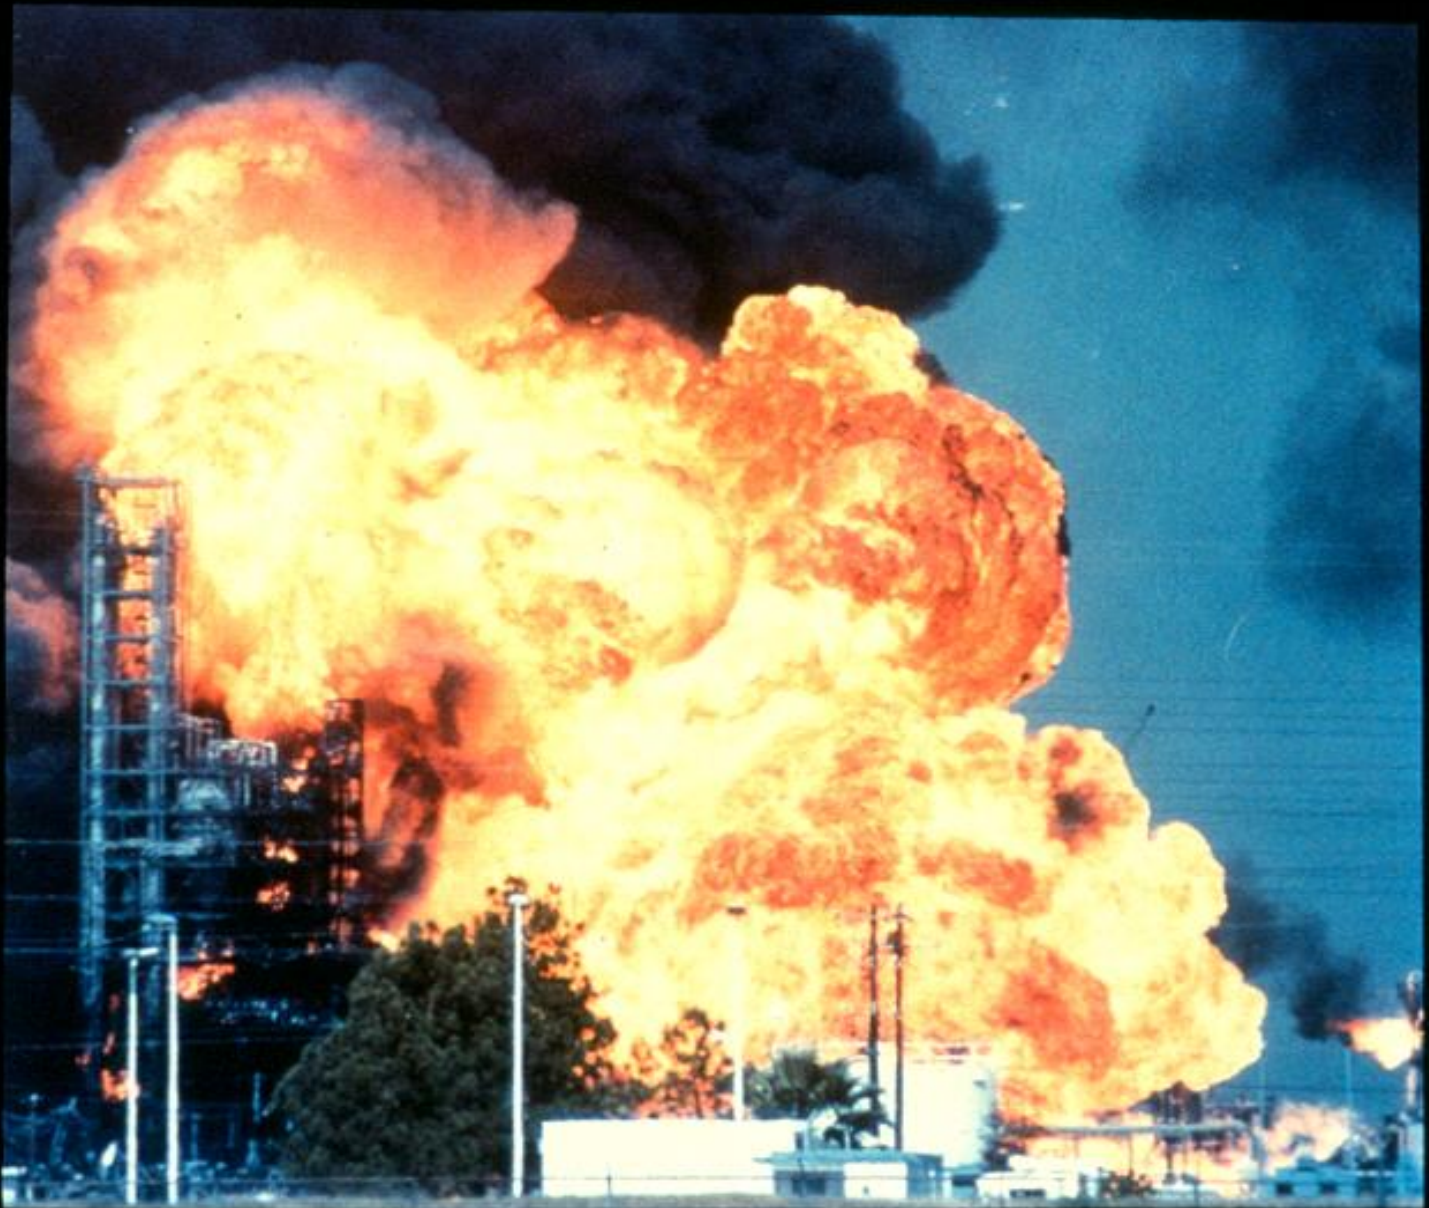
- Vapor released from disassembled settling leg
- High operating pressure (600 psi): 99% of reactor contents dumped in a few sec.
- Huge unconfined vapor cloud formed & moved rapidly downwind
- Potential ignition sources: forklift, diesel crane, welding & torch cutting, gas-fired catalyst activator (open flame), vehicles near polyethylene plant office

- Ignition within 90-120 seconds
- Second explosion 10-15 min. later: two 20,000-gal. isobutane storage tanks
- Third explosion: 15-30 min. later: another polyethylene plant reactor failed catastrophically

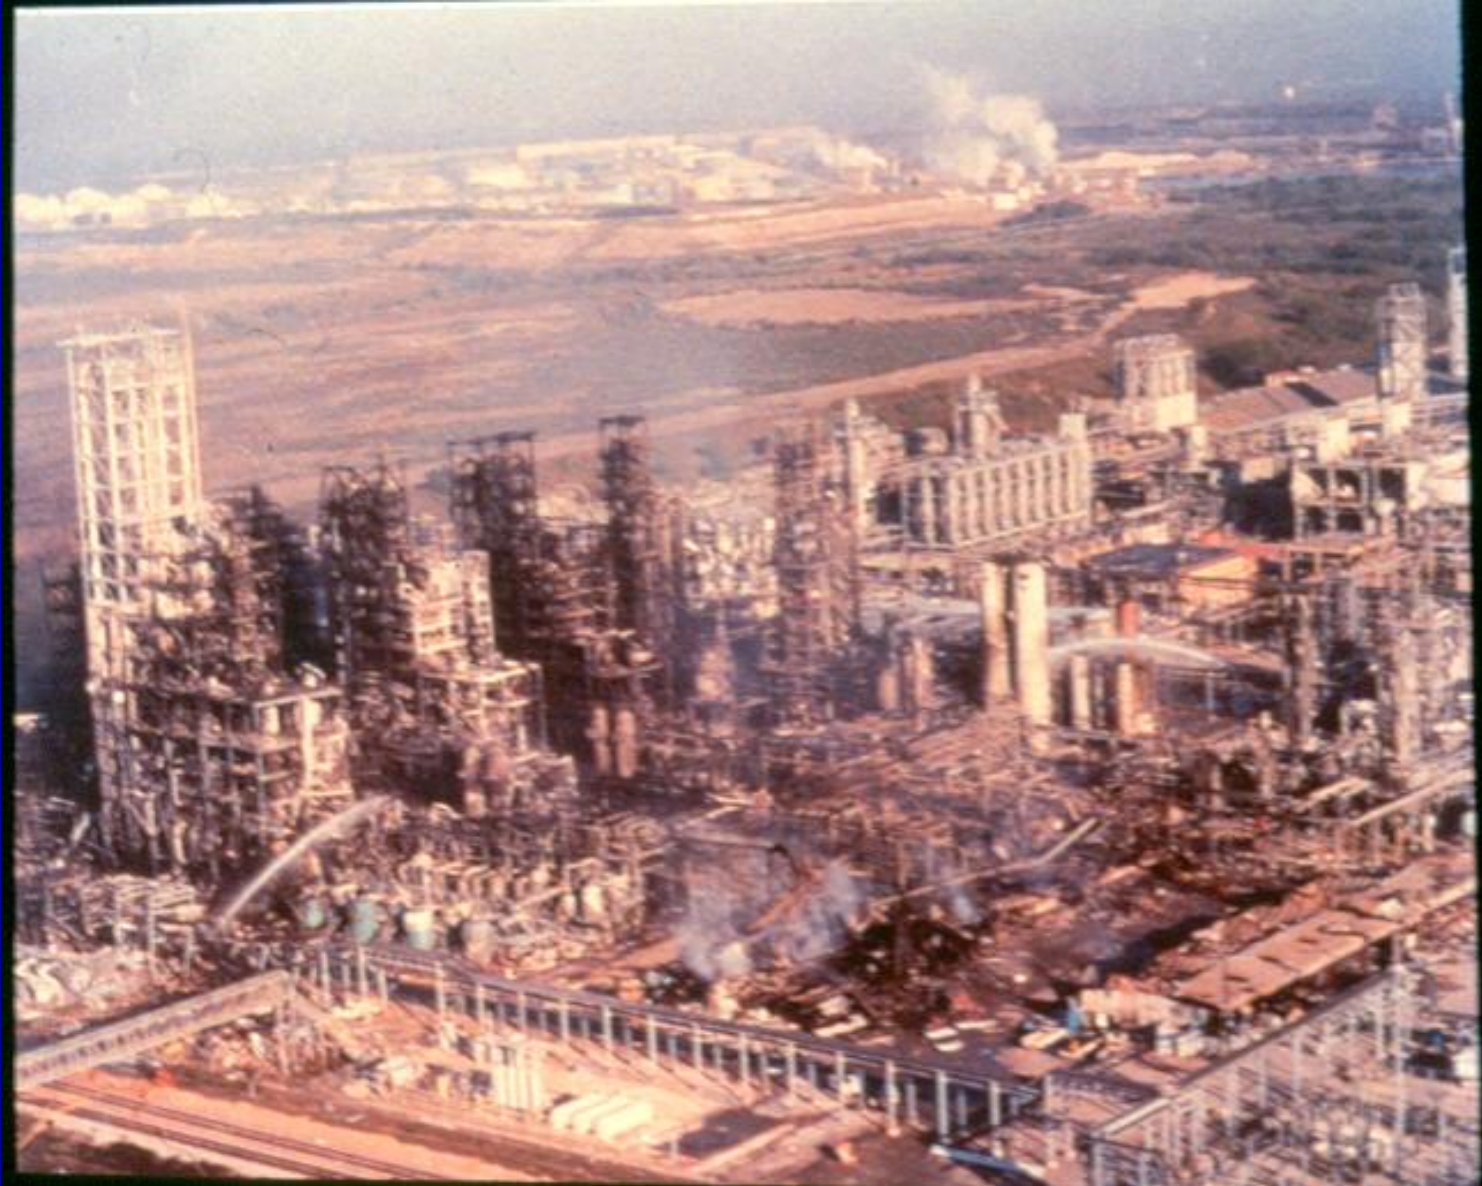
- Common process/fire-fighting water system
- Fire hydrants sheared off by blast
- Inadequate water pressure
- Regular service fire pumps disabled by fire
- Only 1 backup diesel fire pump available
- Hose laid to remote water sources
- Fire control by CIMA members, local fire departments, Phillips foam trucks
- Control within about 10 hrs.
