Article in *Journal of Loss Prevention in the Process Industries* · January 2006

# A study of storage tank accidents

James I. Chang<sup>a,\*</sup>, Cheng-Chung Lin<sup>b</sup>

## Abstract

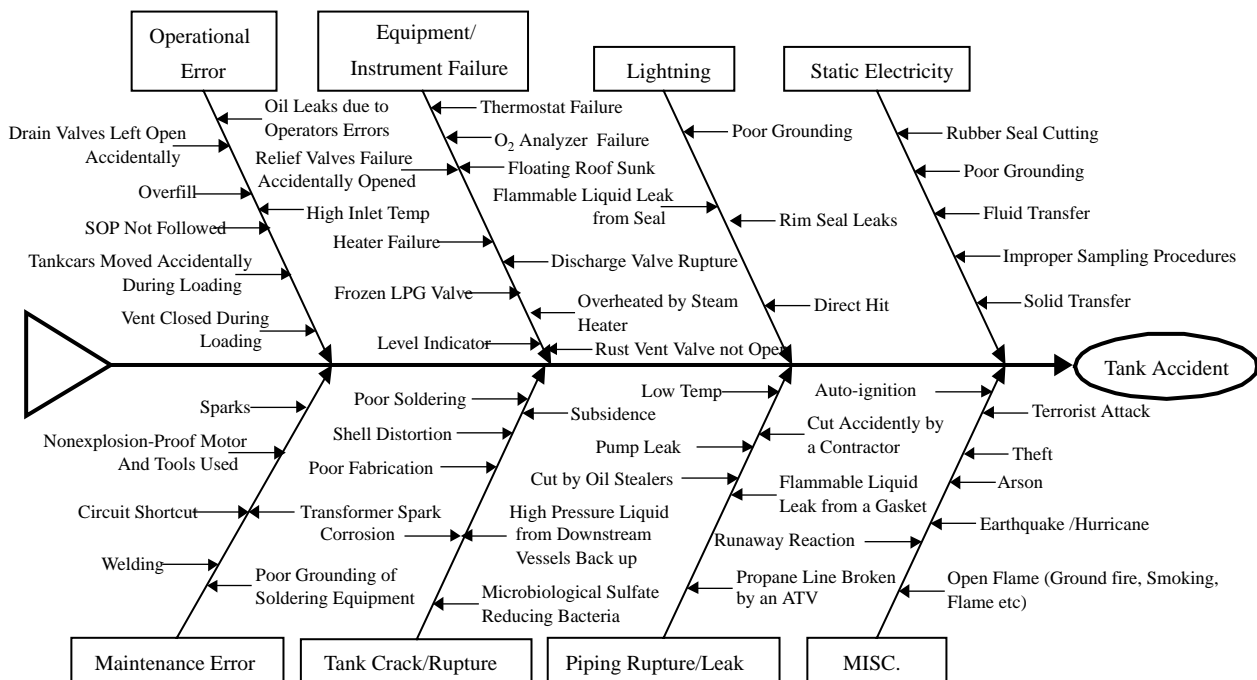
Fig. 1. Fishbone diagram of accident causes.

most frequent cause. The rest were operational error, equipment failure, sabotage, crack and rupture, leak and line rupture, static electricity, open flames etc. To illustrate causes and effects, a fishbone diagram as shown in Fig. 1 was developed. A fishbone diagram as shown in Fig. 2 was also developed for the prevention of accidents.
