A TECHNICAL ANALYSIS OF THE BUNCEFIELD EXPLOSION AND FIRE

M. Sam Mannan

Mary Kay O'Connor Process Safety Center, Artie McFerrin Department of Chemical Engineering, Texas A&M University System, College Station, Texas 77843-3122, USA; Tel: (979) 862-3985; e-mail: mannan@tamu.edu; <http://process-safety.tamu.edu>

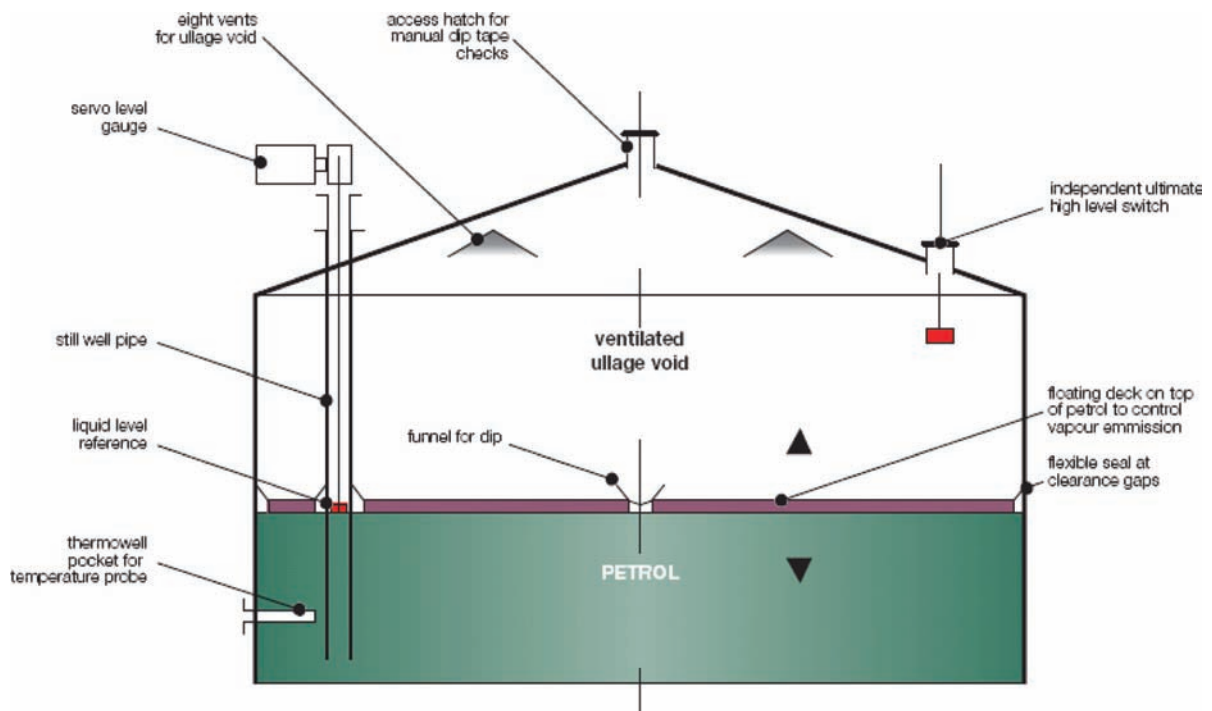
Figure 2. Schematic of Tank 912 which overflowed from the 8 breather holes. (Source: <http://www.buncefieldinvestigation.gov.uk/images/index.htm>)

The flow rate to Tank 912 was initially 550 m³/hr. From approximately 3 am on December 11, 2005, the Automated Tank Gauging System indicated that the level for Tank 912 remained static at two-thirds full. During this time the tank temperature for Tank 912 continued to rise. At approximately 5:35 am on December 11, 2005, the fuel in Tank 912 began to overflow.

The site and neighboring office buildings were equipped with more than a dozen CCTV cameras that recorded images of a visible mist shortly before the explosion. Witness statements also corroborate the spread of a mist-like cloud and reports of the smell of gasoline. At approximately 5:53 am on December 11, 2005, the flow rate to Tank 912 increased to 890 m³/hr. By about 6 am on December 11, 2005, approximately 300 metric tons of unleaded gasoline had overflowed from Tank 912.
