The Buncefield Investigation

Third progress report

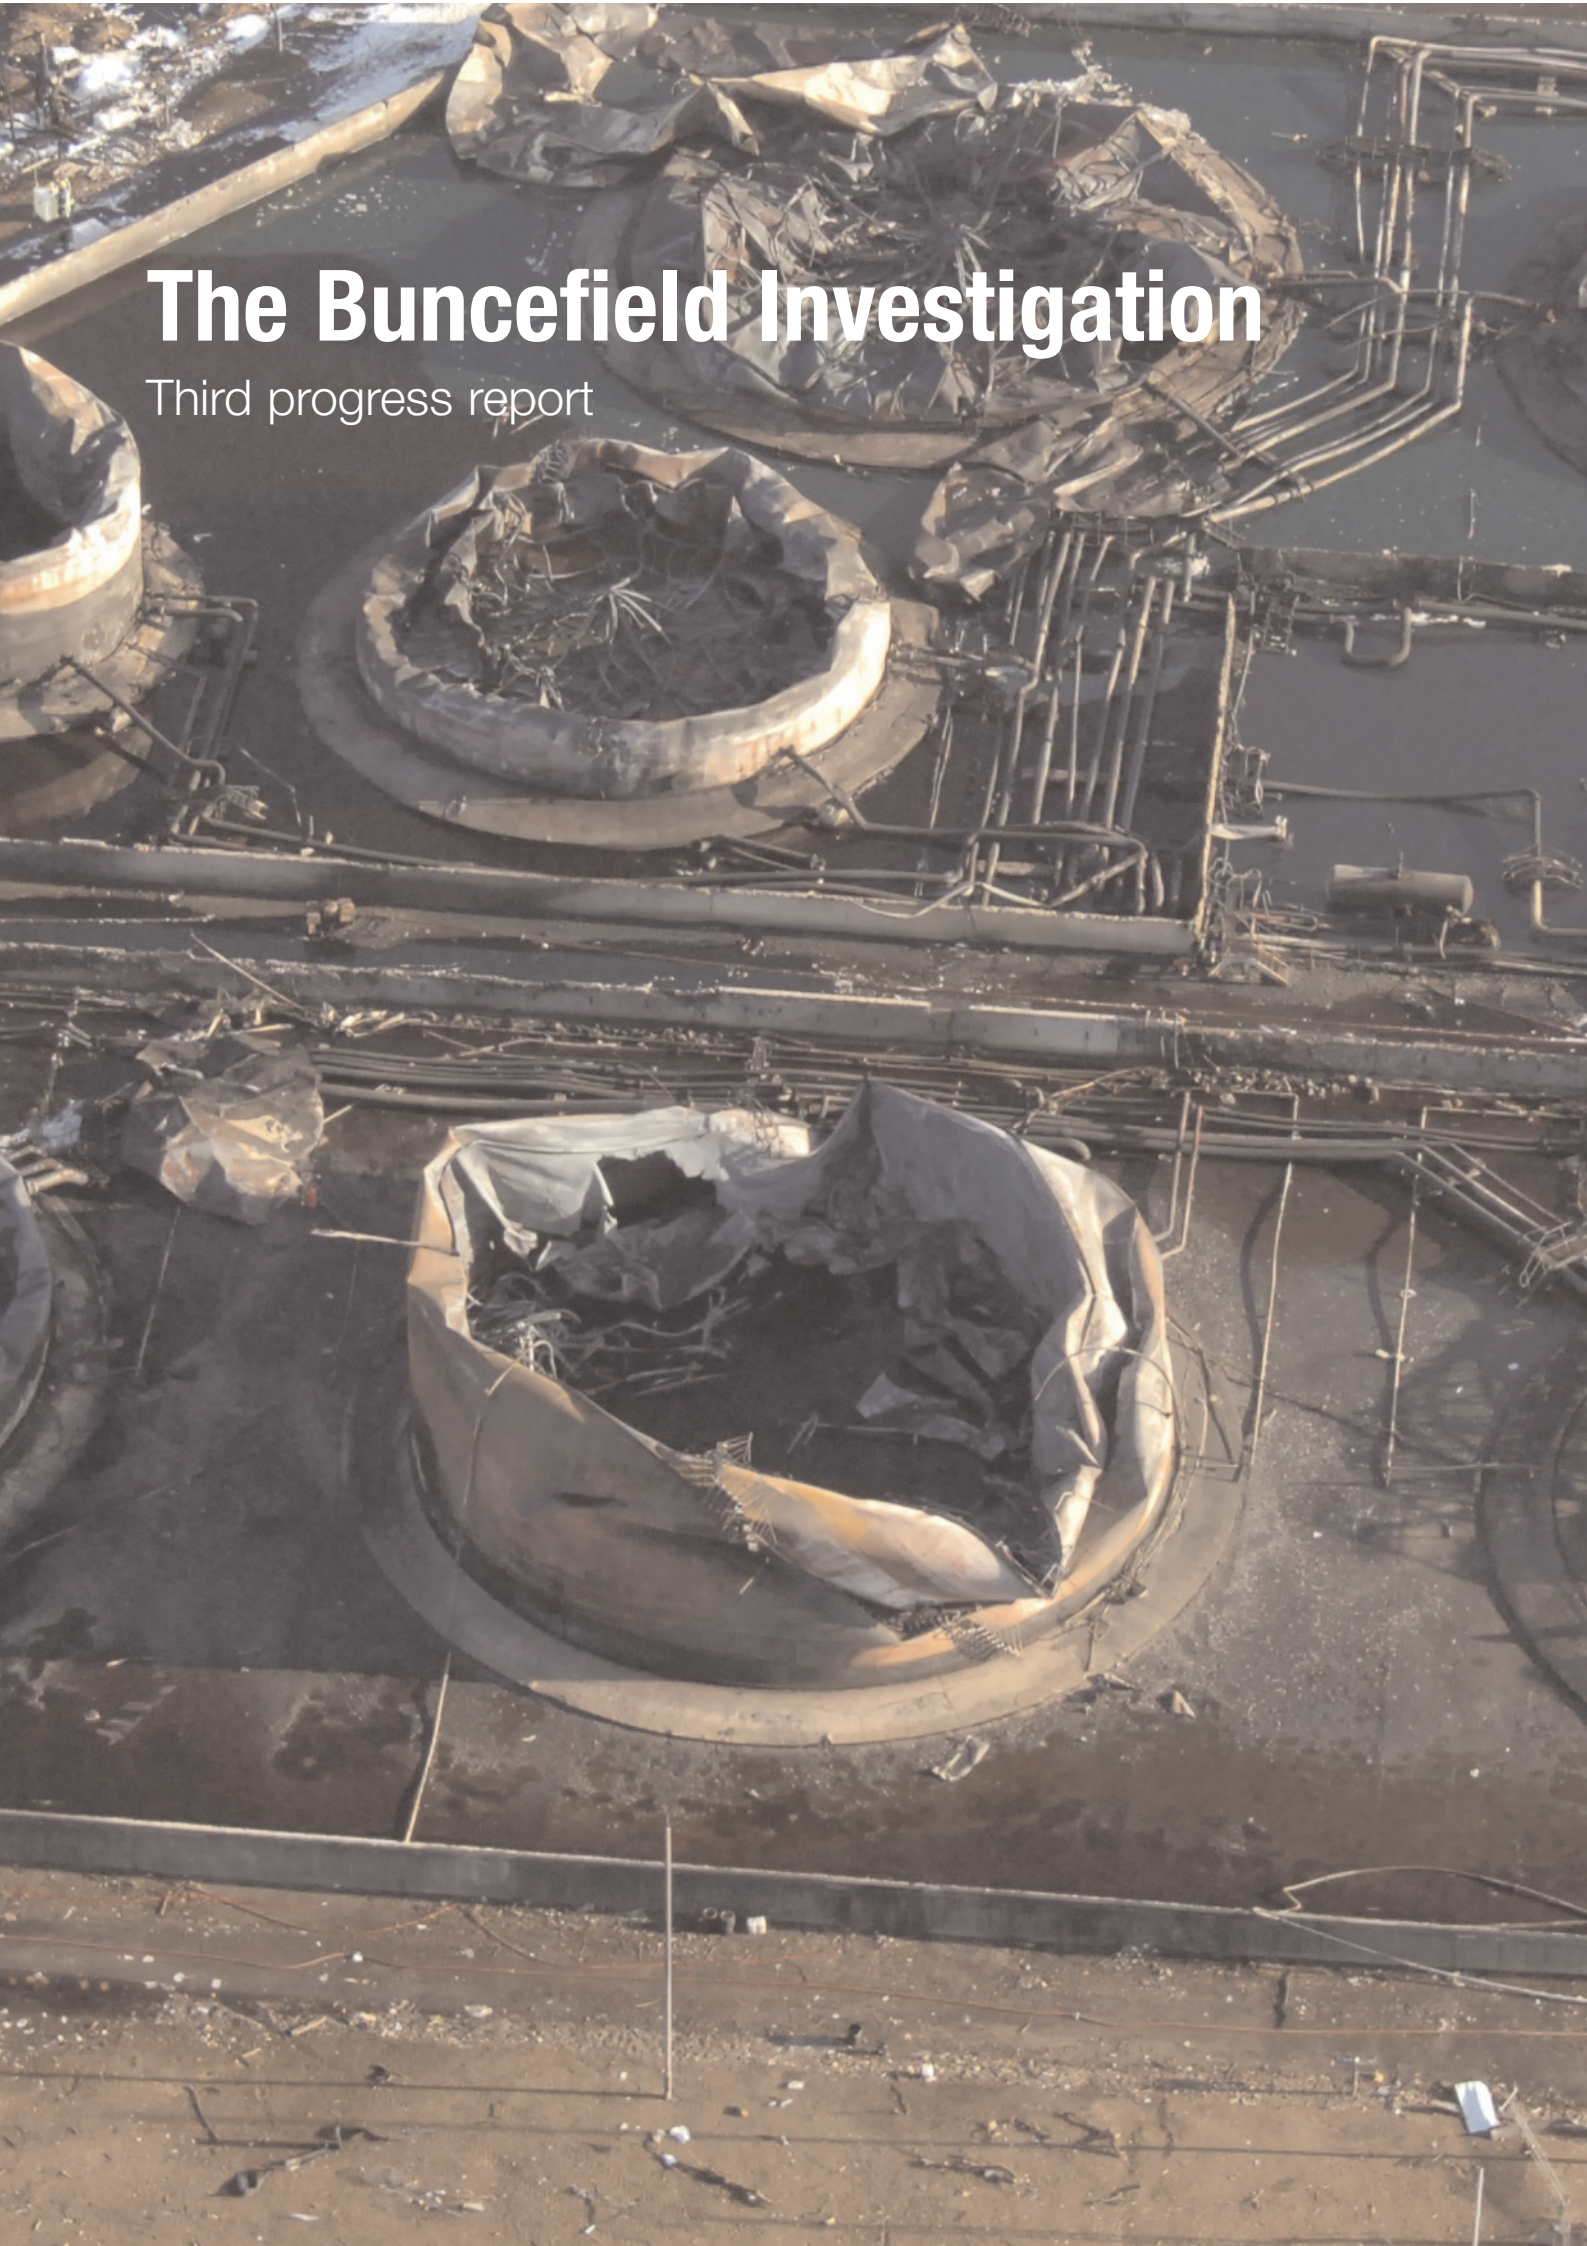
Photograph on front cover shows Tank 912 and is courtesy of the Chiltern Air Support Unit

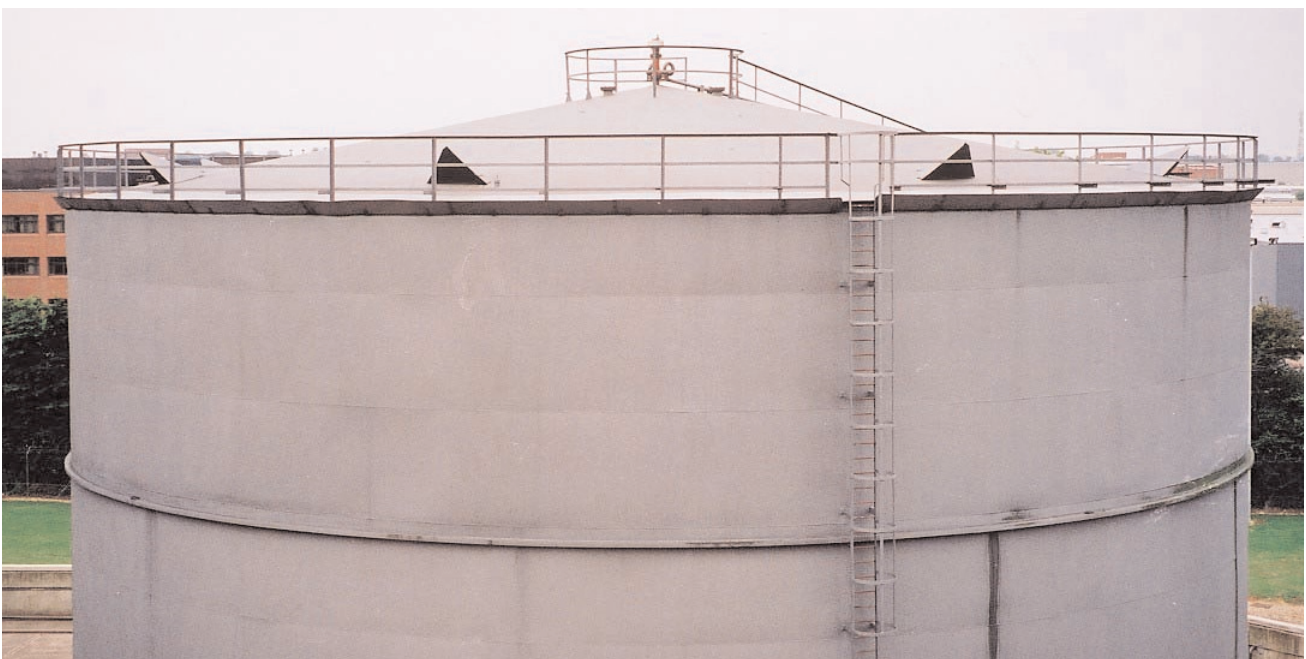
Figure 3 Tank top details before the incident

28 Therefore overfilling of Tank 912 would have resulted in flow from the breather holes at the top of the tank. There were eight of these, each triangular in section with an area of 0.07 m^2 , as can be seen in Figure 3 which is a photograph of one of the tanks in bund A taken shortly after construction.

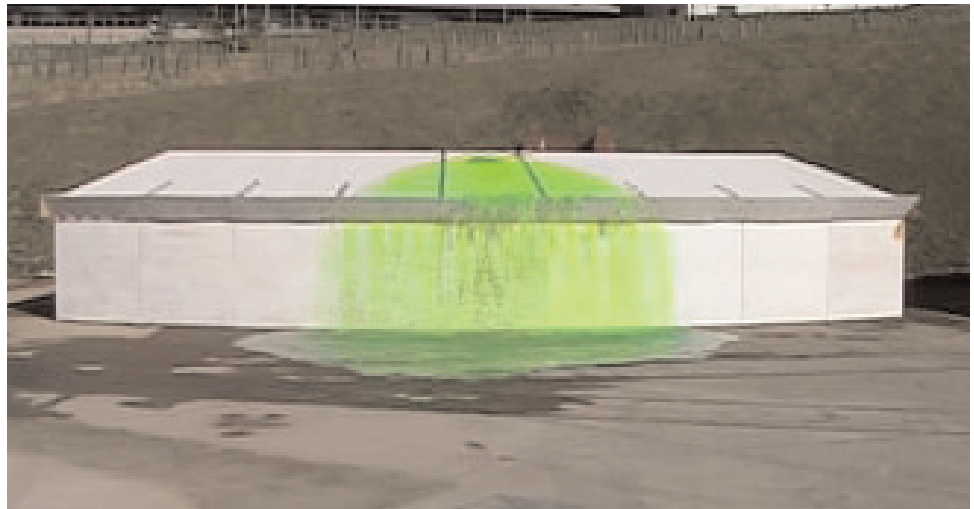
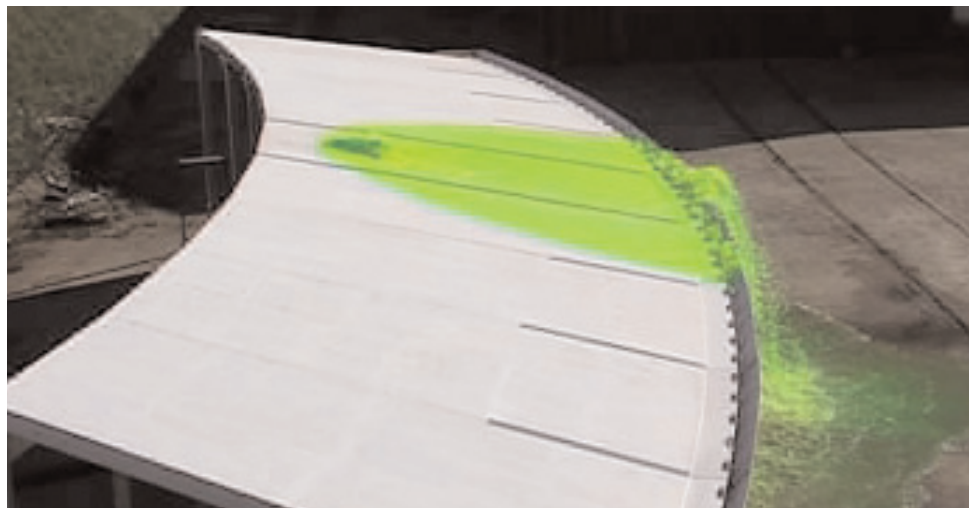
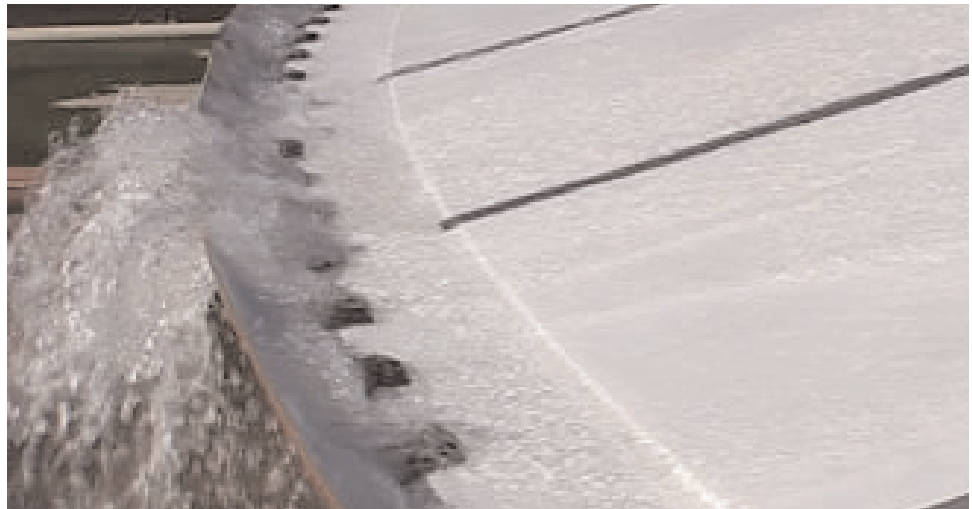
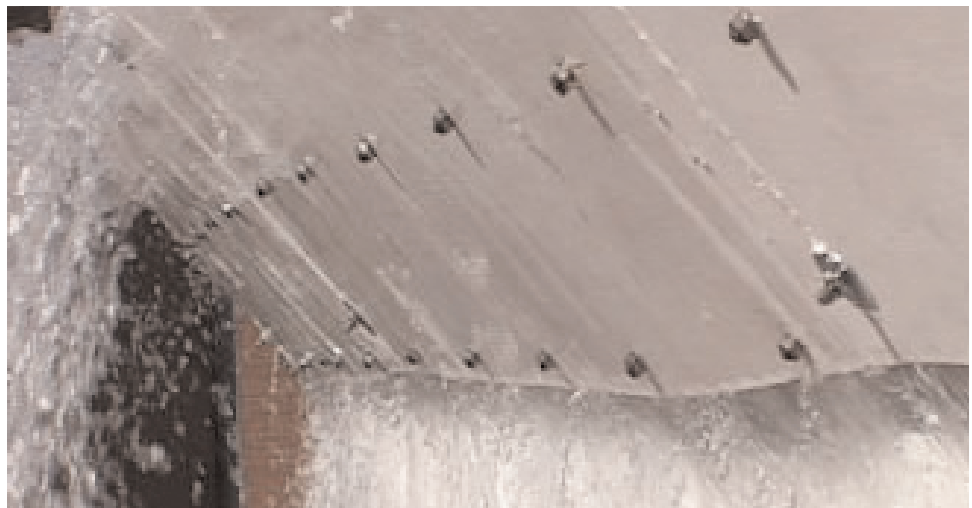
Figure 4a-d Liquid flow from the breather holes on the tank top

32 These tests demonstrate that the deflector plate was effective in channelling the majority but not all of the liquid onto the tank wall, but only spread it laterally over approximately one third of the wall. Images captured from video records are shown in Figure 4.

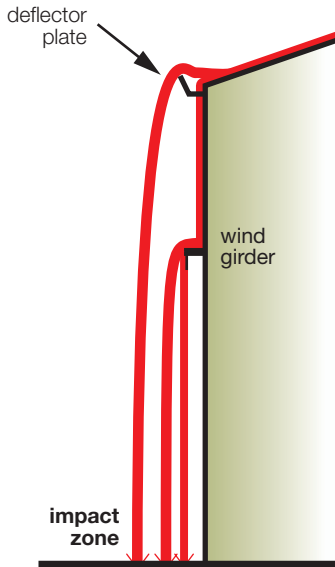
36 The general features of these processes during an overflow are illustrated schematically in Figure 5.

37 The conclusion of this work is that the flow is likely to be very efficiently fragmented, and would create relatively small droplets falling freely through air around the tank. These conditions would promote the evaporation of the lighter chemical components of petrol, eg butanes, pentanes and hexanes.

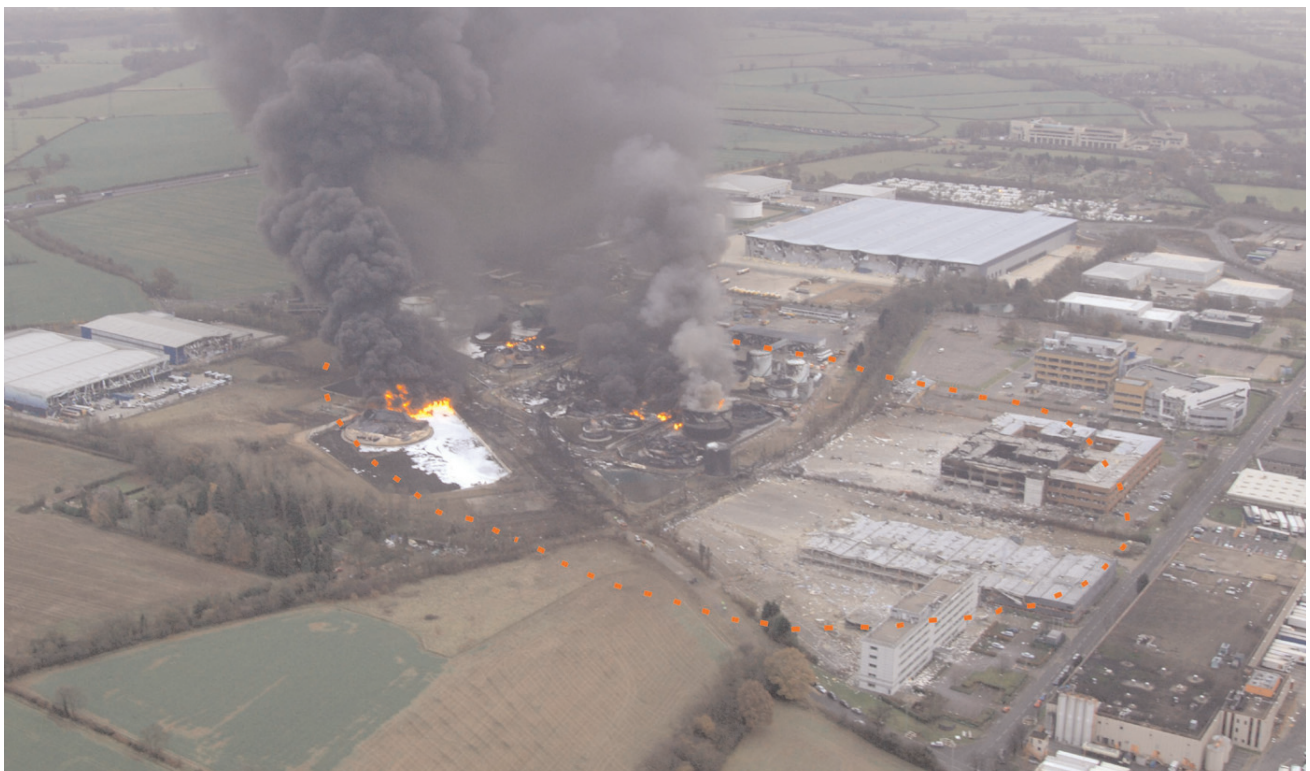
Figure 6 Extent of burn damage (indicated by dotted line)

39 Aerial pictures of the site have confirmed preliminary conclusions about the extent of the burn damage shown in Figure 5 of the first progress report. This is also shown by the dotted line in Figure 6. This is indicative of the extent of the flammable vapour cloud.

HOSL East site. This is a little way beyond the extent of the burn damage shown in Figure 6. According to witnesses, the depth of the visible mist varied from about 1 m in the area between bund A and the loading gantry to between 5 and 7 m in Three Cherry Trees Lane.

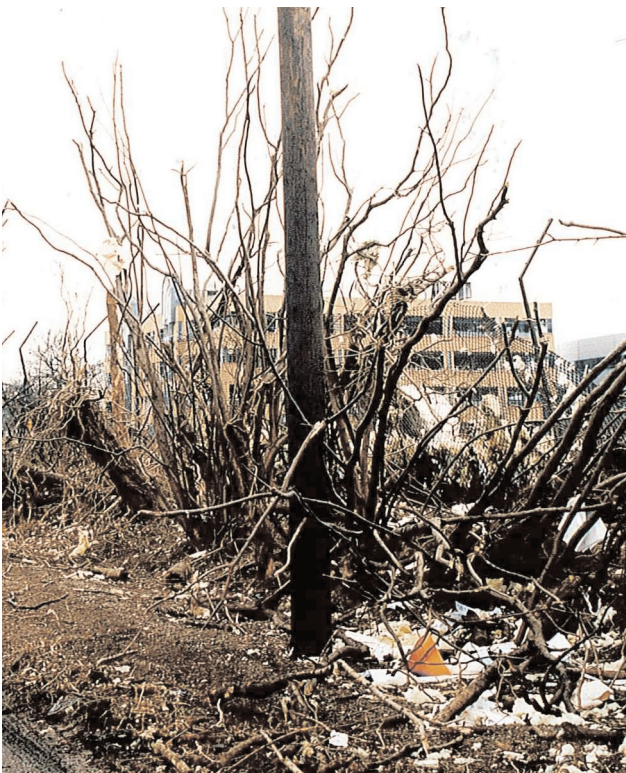
42 The telegraph pole shown in Figure 7 is in Buncefield Lane relatively close to the wall of bund A containing Tank 912. The bottom part of the pole shows soot blackening, characteristic of objects exposed to burning of a very rich vapour mixture. Video records of the fire confirm that this area was not affected by the smoke plume during the fire.

Figure 7 A telegraph pole in Buncefield Lane, showing sooting on lower half

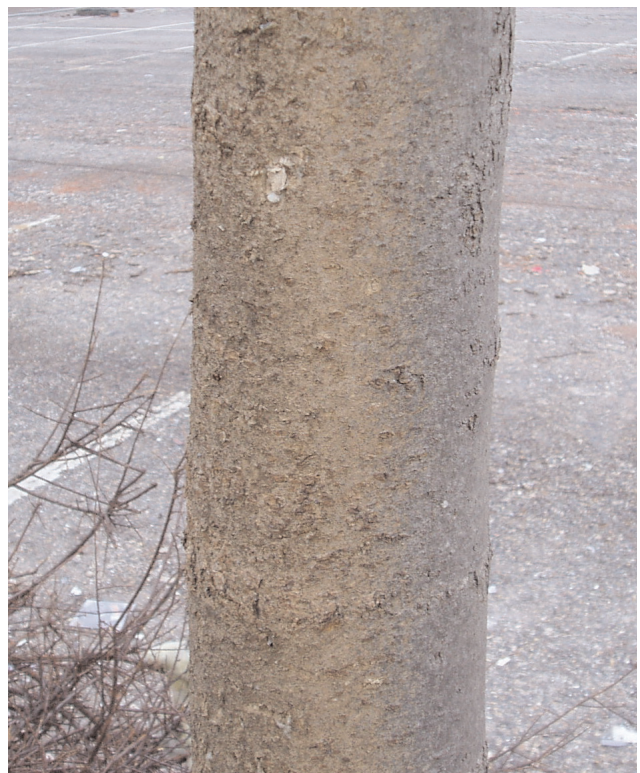
43 The tree trunk in the Northgate car park shown in Figure 8 is much further from the site and has been exposed to an explosion propagating in a more dilute vapour mixture with a composition close to the optimum for complete combustion. There is no soot on exposed surfaces but the left-hand side facing the camera has been deeply abraded by grit driven into it at high speed by the explosion. Examples of this kind of damage were found across most of the area covered by the Northgate and Fuji car parks.

Figure 8 Part of a tree trunk in the Northgate car park showing abrasion

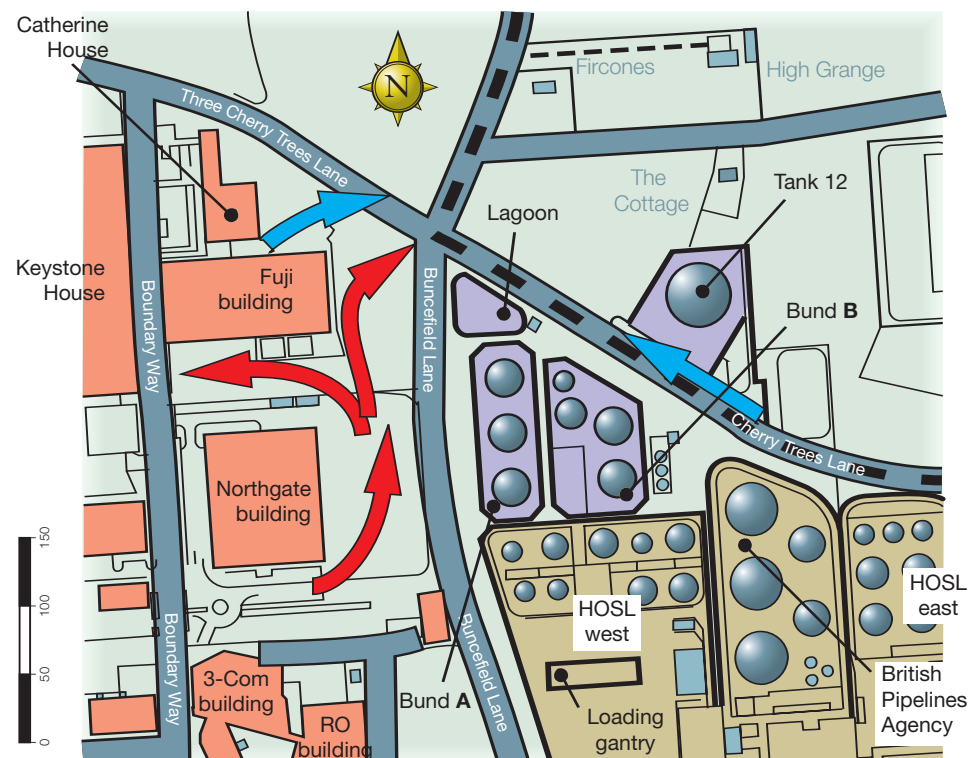
Figure 9 Showing main and secondary explosion propagation

56 Furthermore there is evidence, from erosion/abrading on just one side of posts and tree trunks, of a powerful explosion having propagated northwards across the Northgate and Fuji car parks, as shown in Figure 8. The movement of objects like fence posts, tree branches etc indicate explosions of lesser magnitude having propagated through other areas bordering on the Buncefield site. The directions of explosion propagation are shown on Figure 9. The main explosion propagation is shown in red with secondary effects in blue.
