# Sinking floating roof of large oil storage tank

*JOIFF 26-6-2017*

*Raymond Bras  
Unified Firebrigade.  
Rotterdam, the Netherlands*

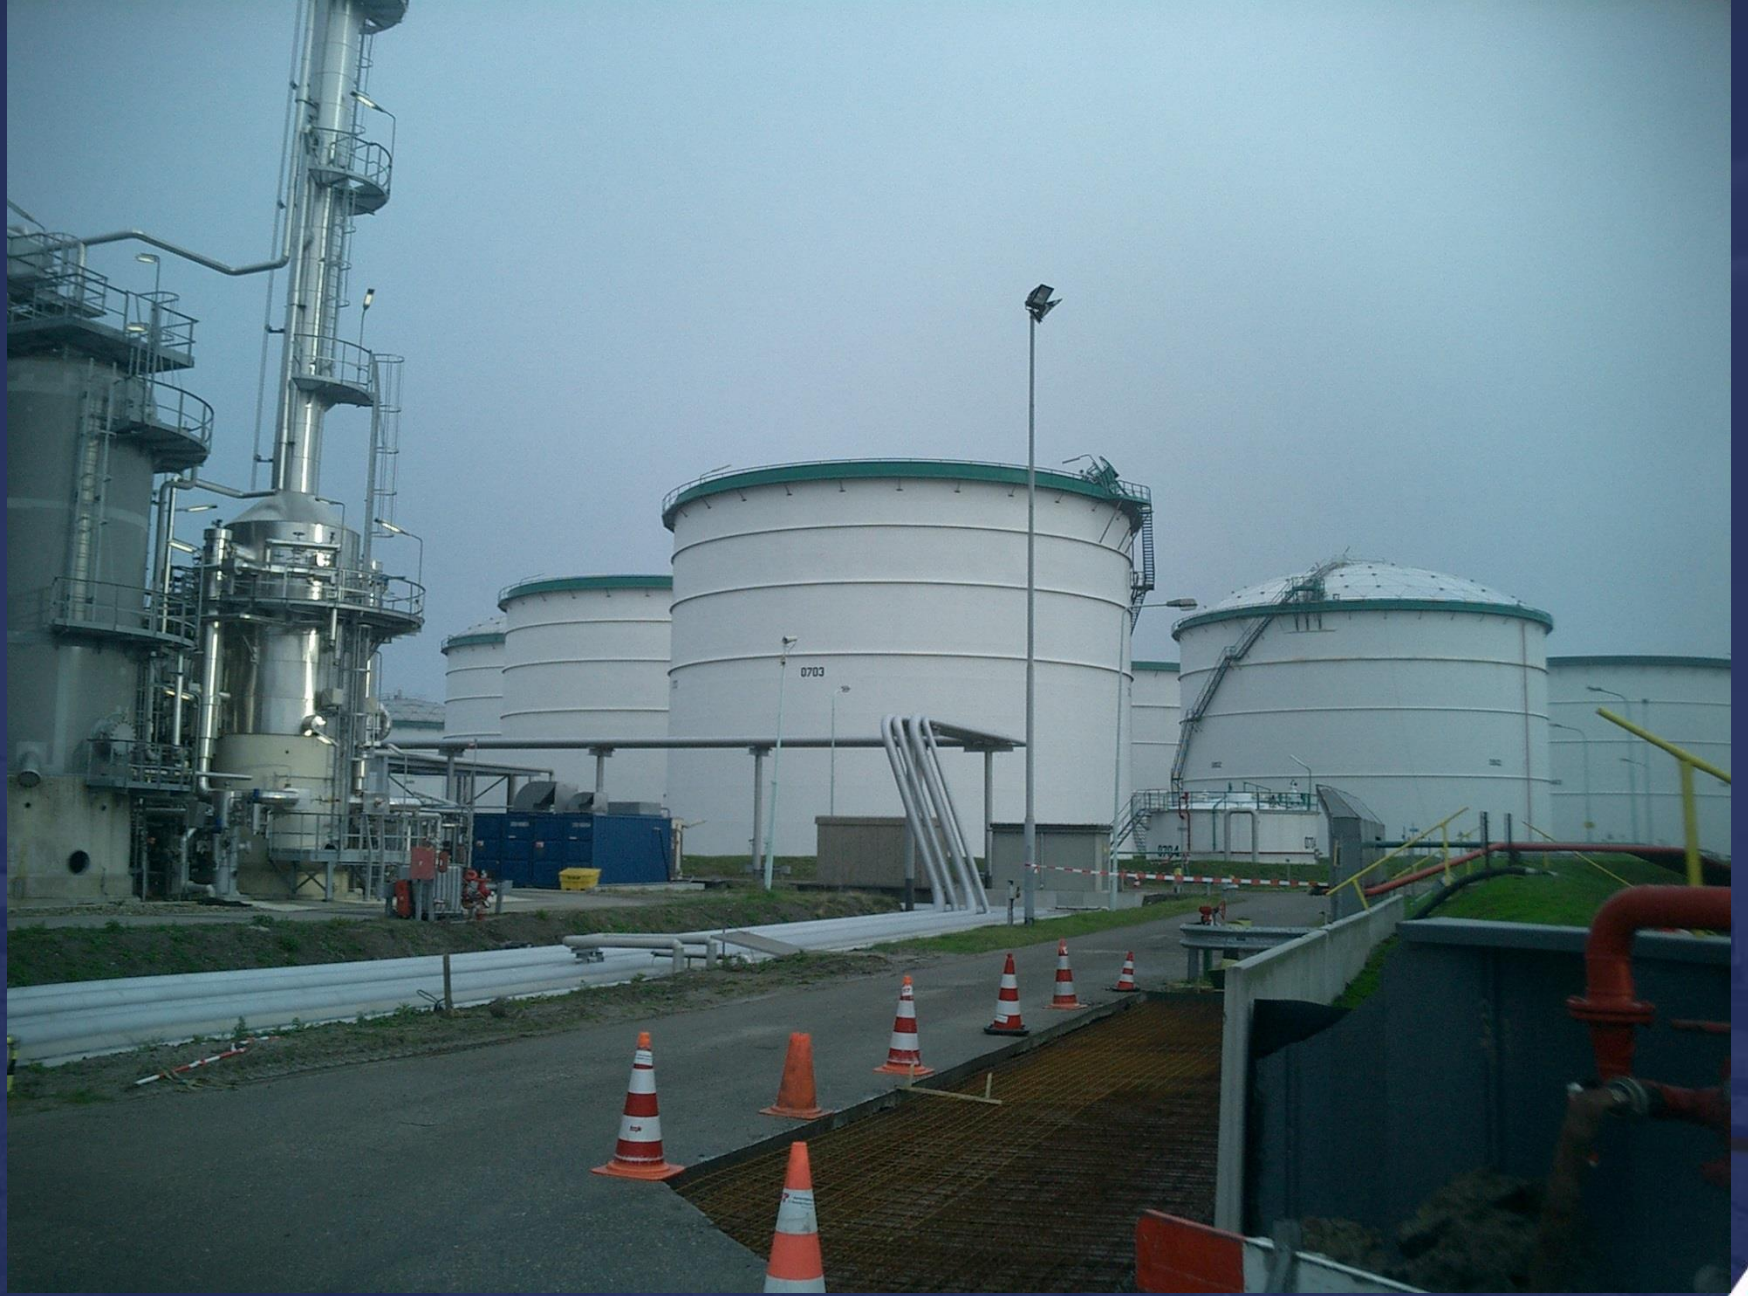
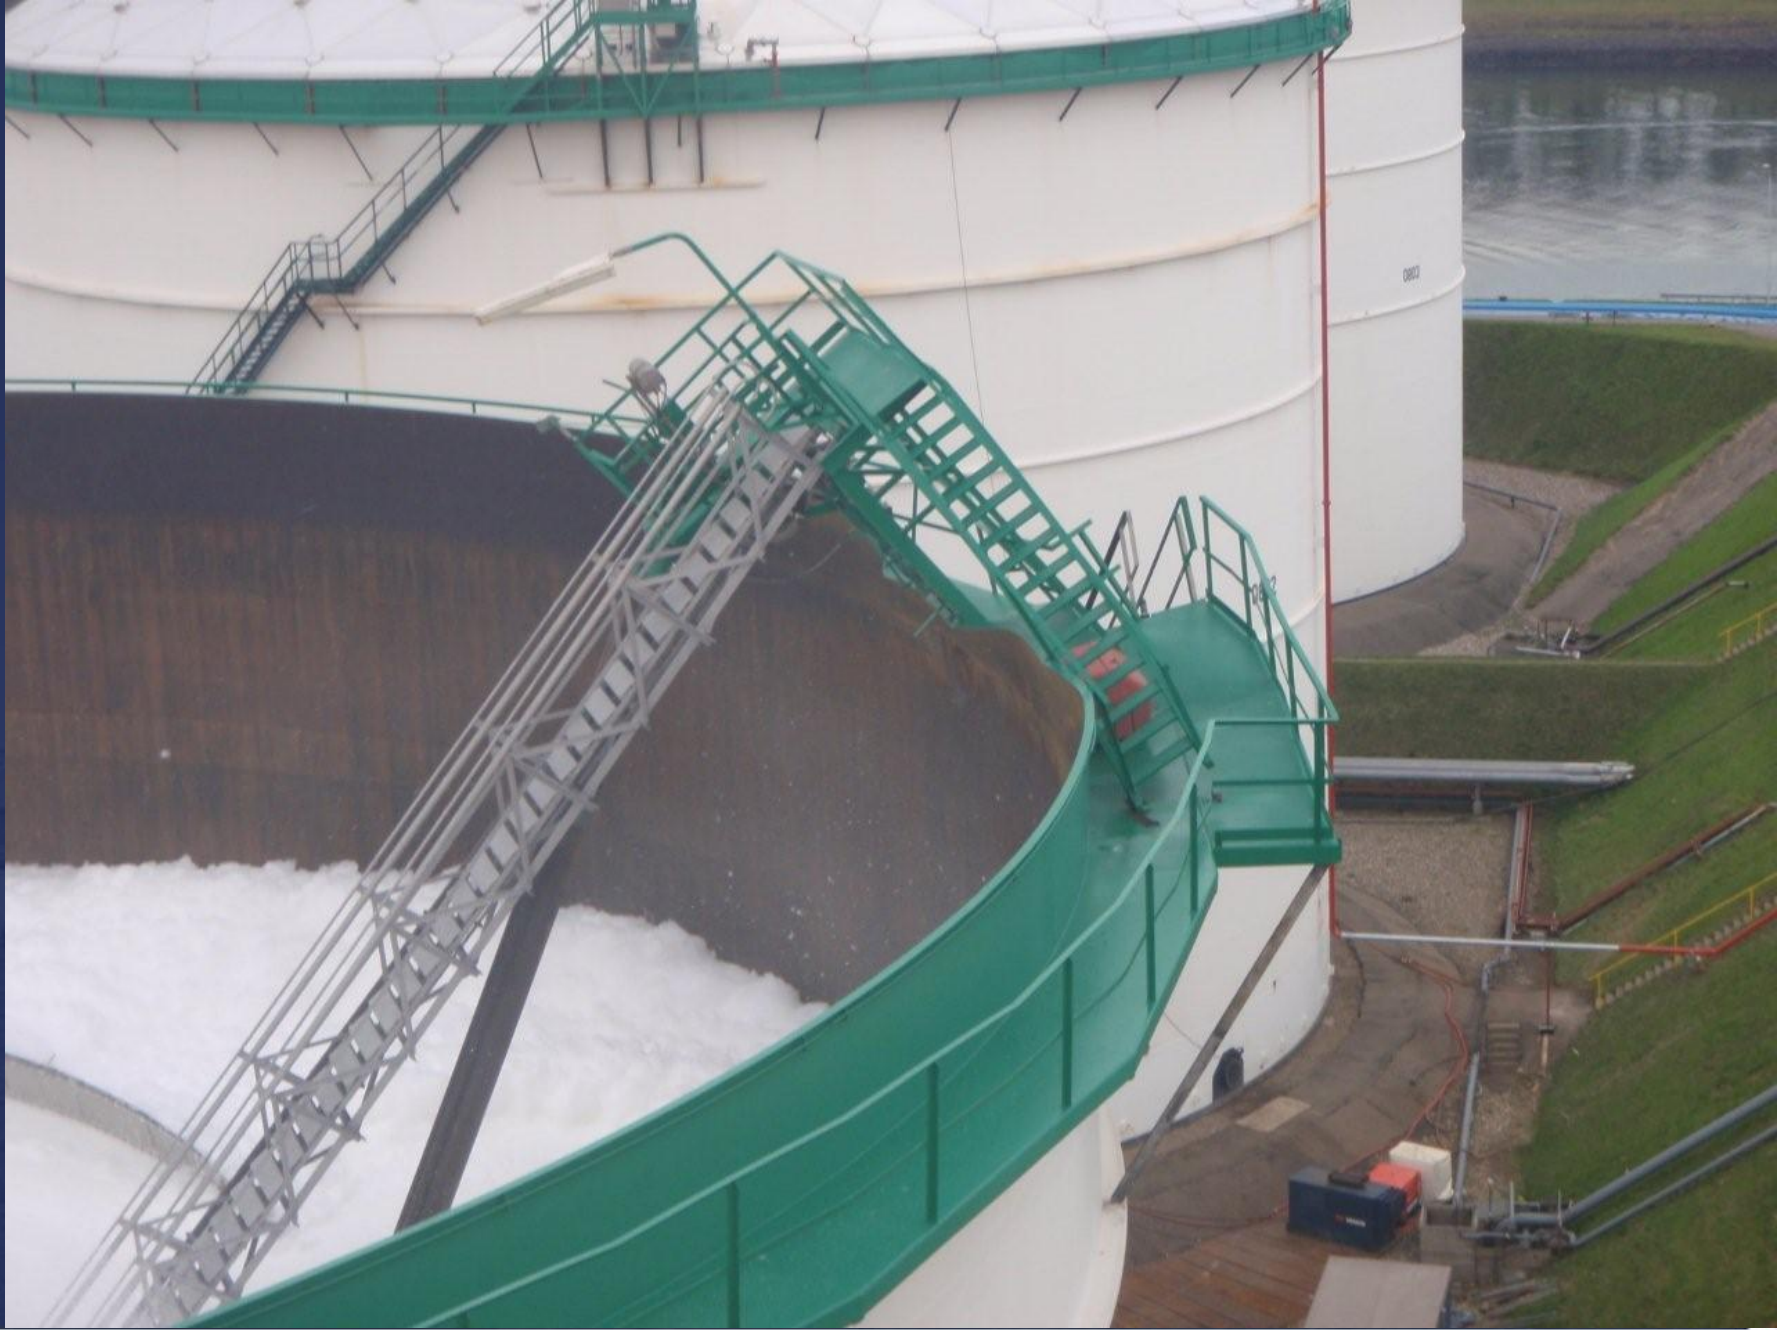
# *Situation when firetruck arrived*

- The roof was still sinking which was paired with a lot of noise and deformation of the tank.
- Fixed firefighting systems were destroyed.
- Several people were running away from the tank.
