The Buncefield Investigation

Third progress report

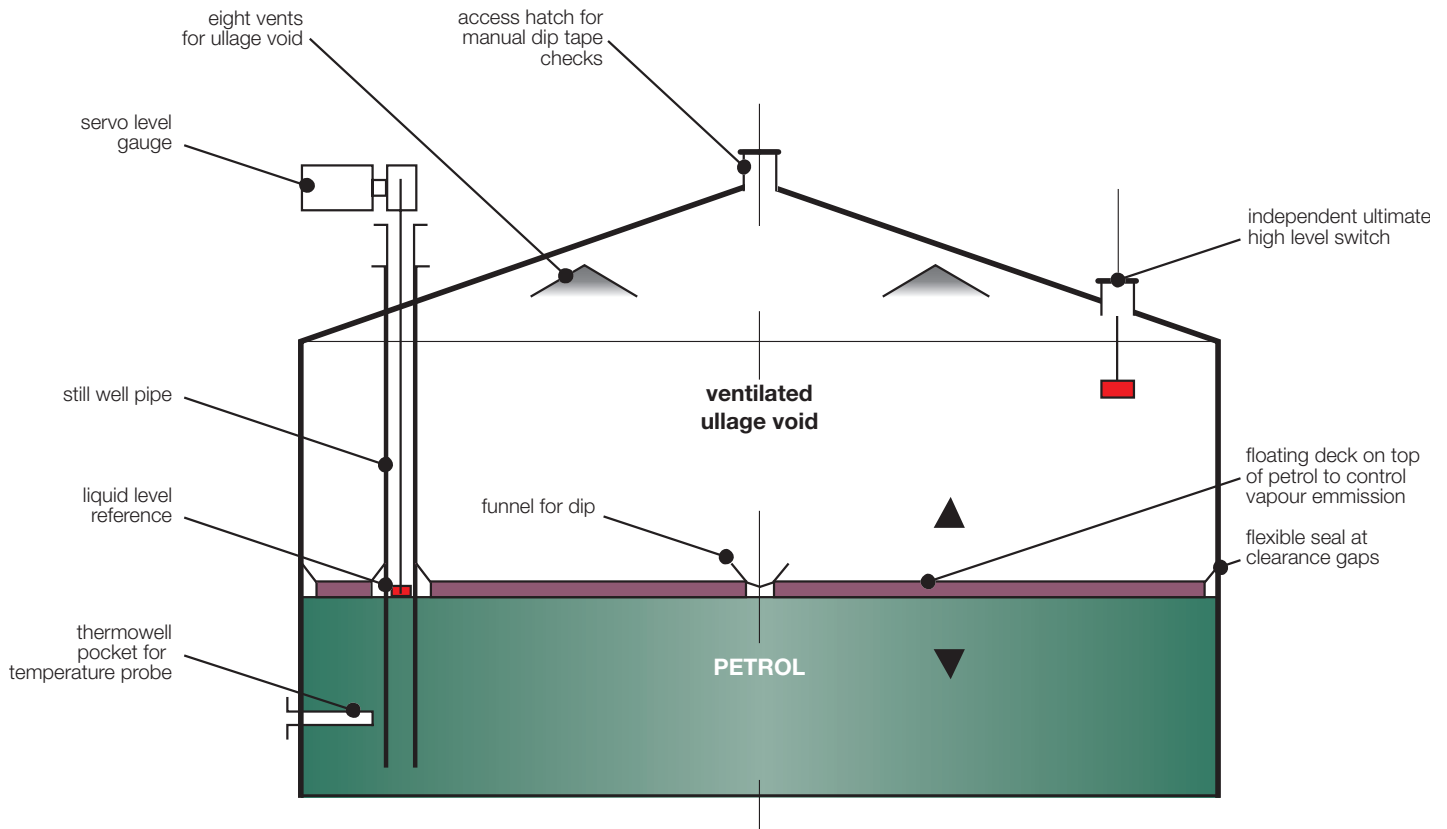
Figure 2 Basic layout of Tank 912

10 All reasonable avenues of investigation have been and continue to be explored but information obtained to date allows stating with some confidence that the initial loss of containment occurred from Tank 912 in bund A, and that this was most likely due to an overflow of unleaded petrol.

12 Figure 2 depicts the basic layout of Tank 912. This was a floating deck tank whereby in addition to the fixed roof, there is a deck inside the tank which floats on the fuel, thus minimising the emission of vapour from the fuel surface.
