28 Workers killed when an explosion occurred in a plant processing Cyclohexane

Department of Process Engineering, UCC

Accident Overview

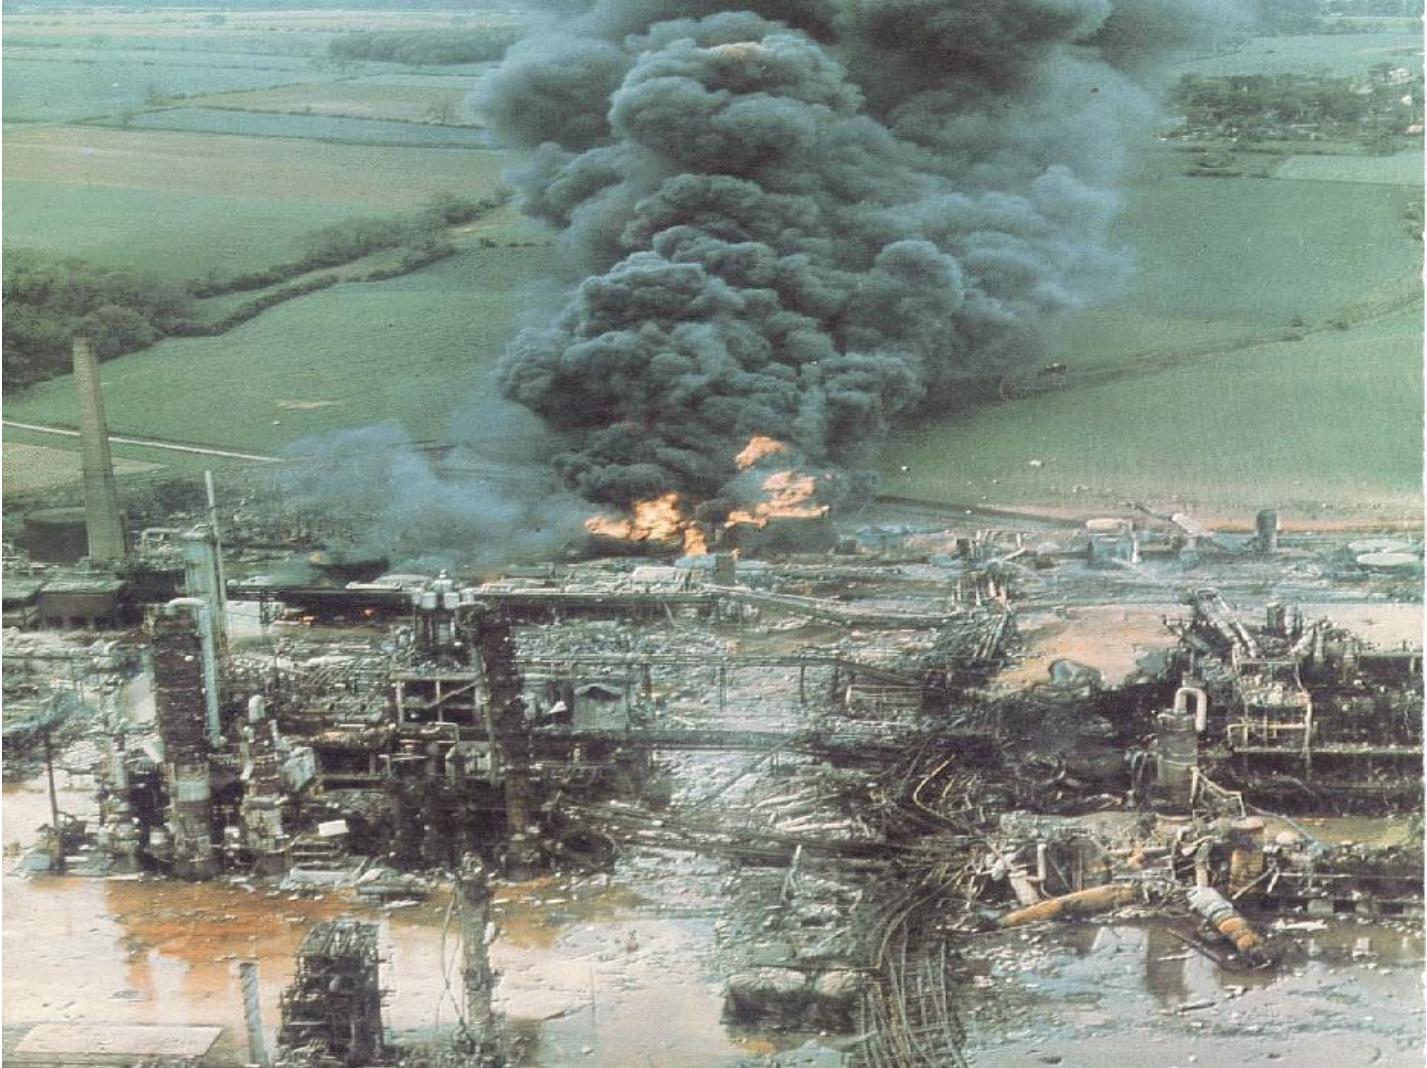
View of the Scene after the Incident

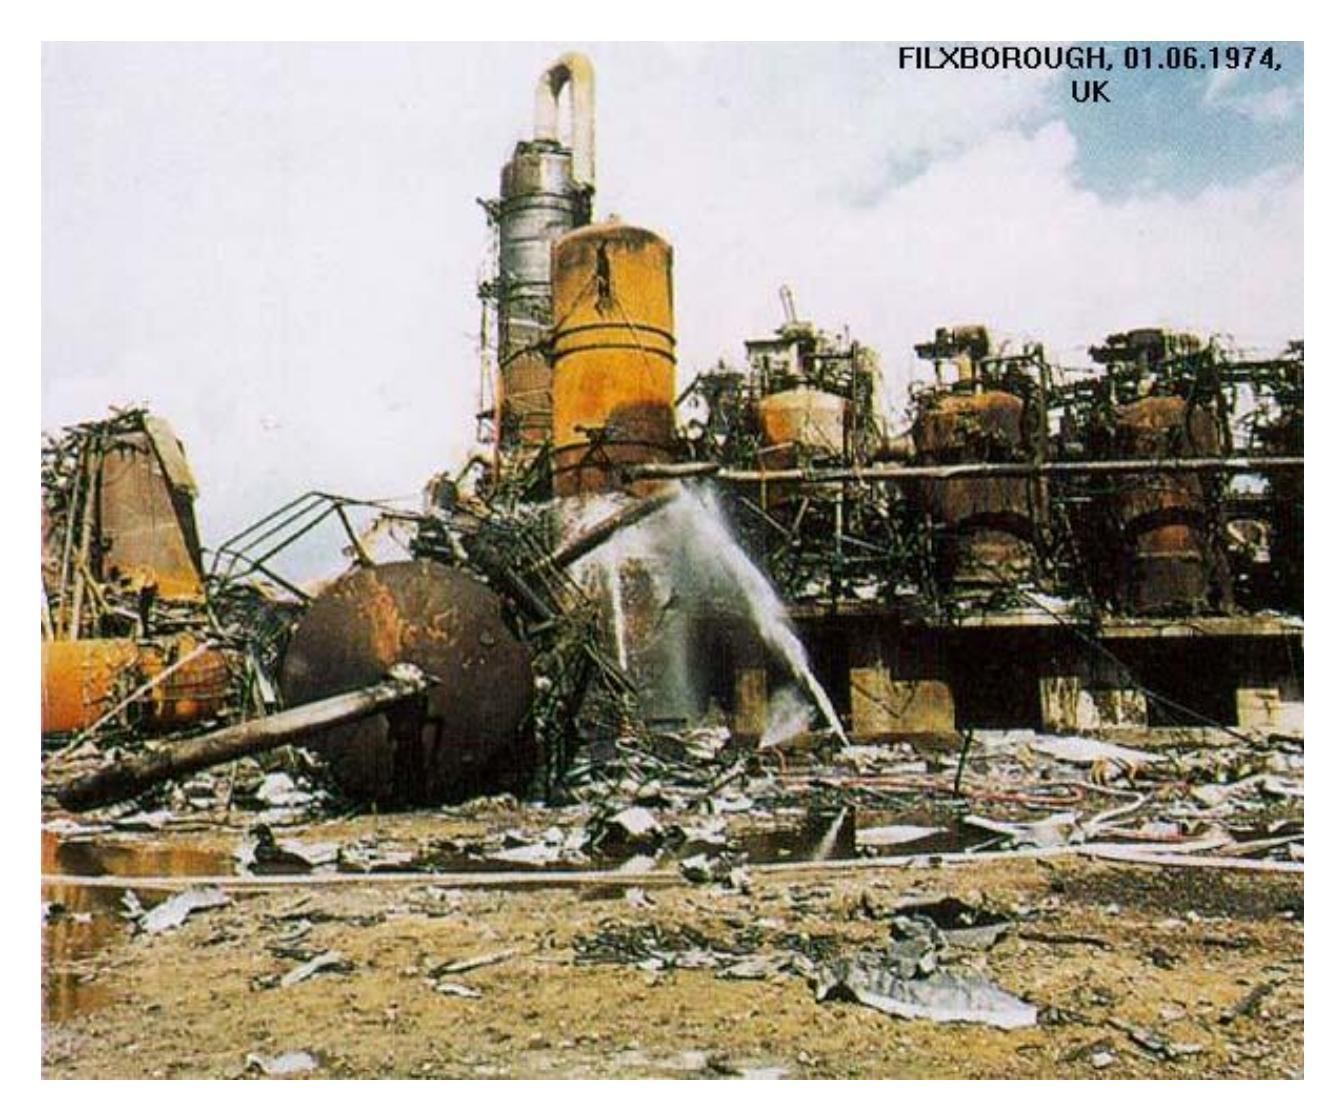
View of the Scene after the Incident

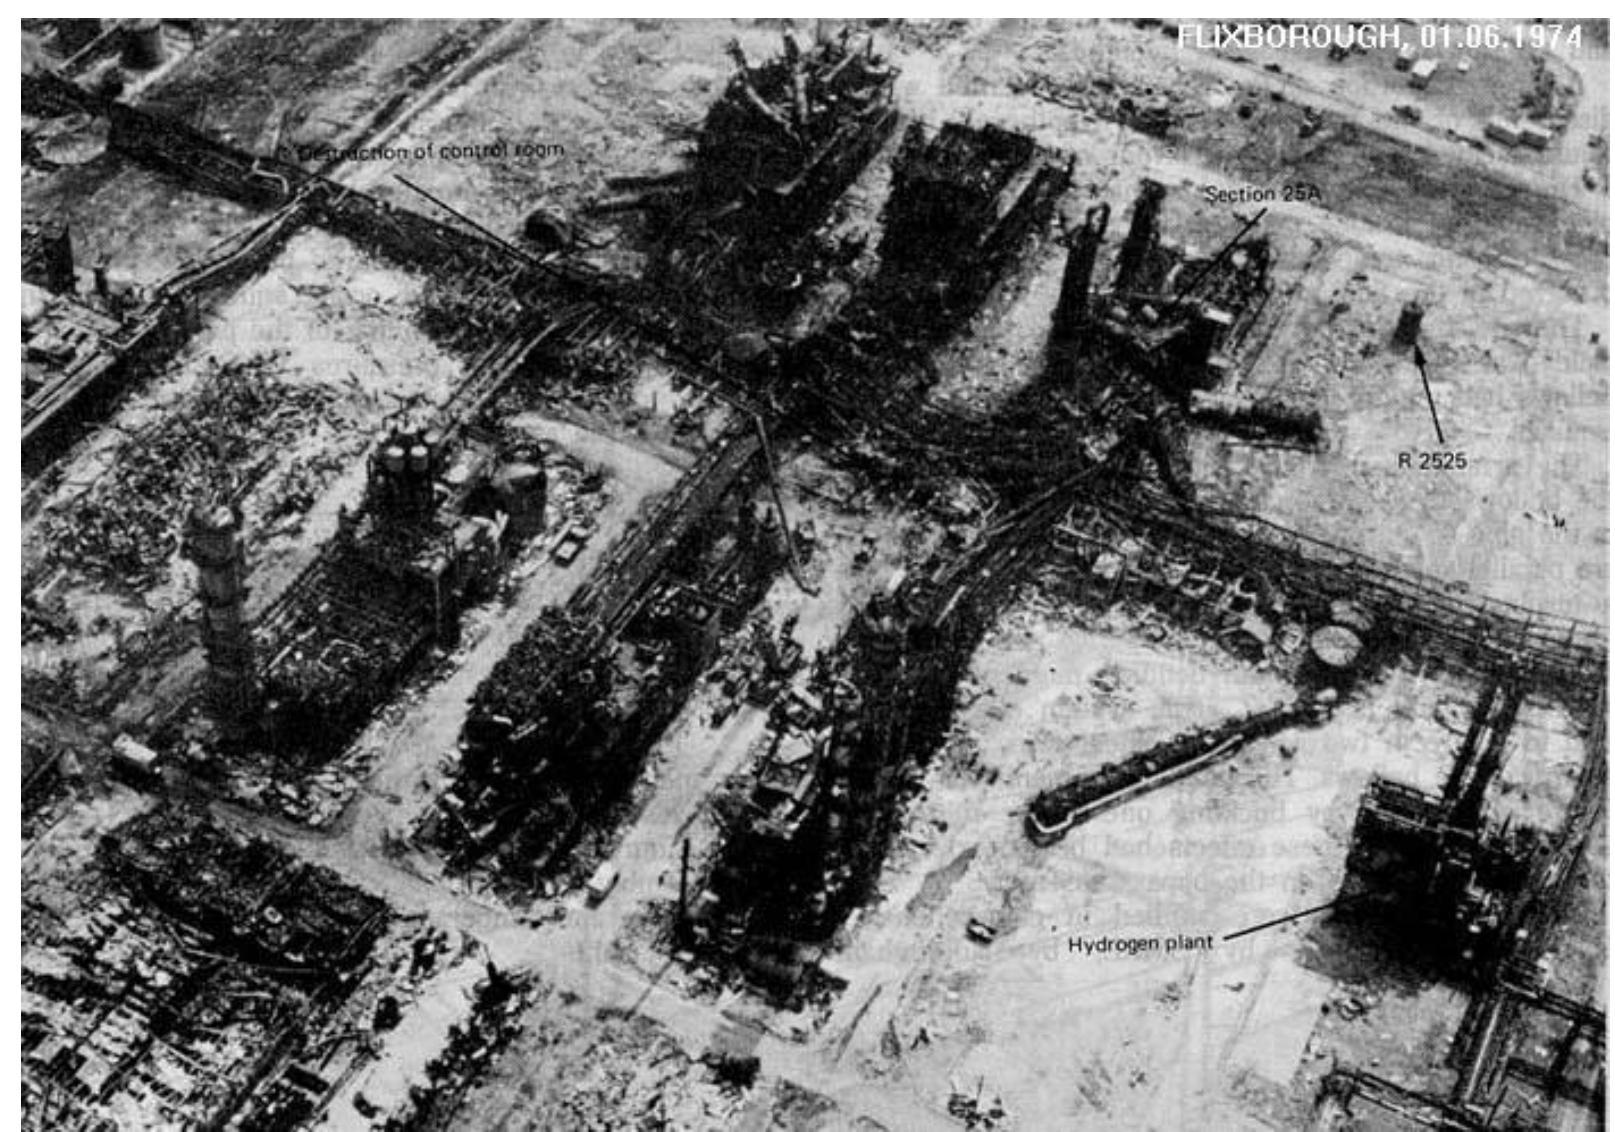
View of the Scene after the Incident

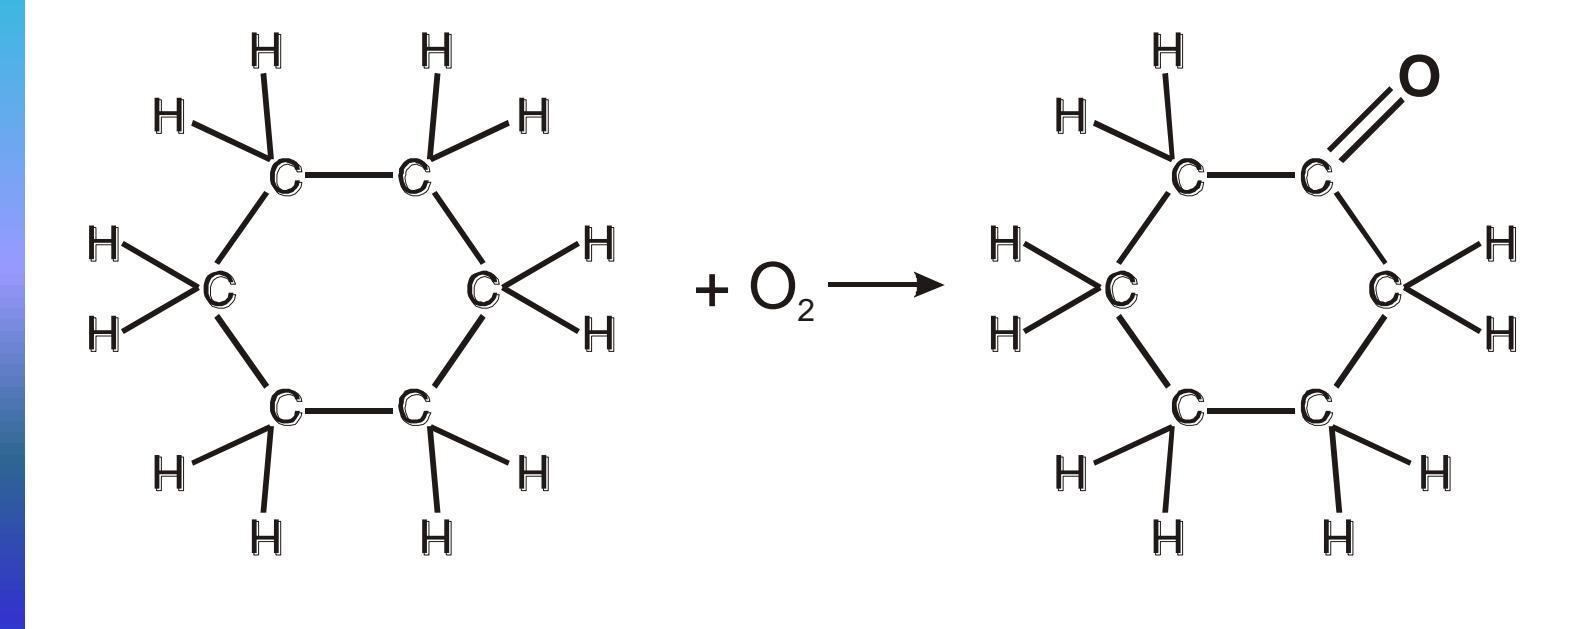
Oxidation of Cyclohexane

Cyclohexane

Cyclohexanone

The Flixborough petrochemical plant was involved in the production of cyclohexanone, a precursor for the manufacture of Nylon. The raw material cyclohexane was oxidised to cyclohexanone by injecting air in the presence of a catalyst.

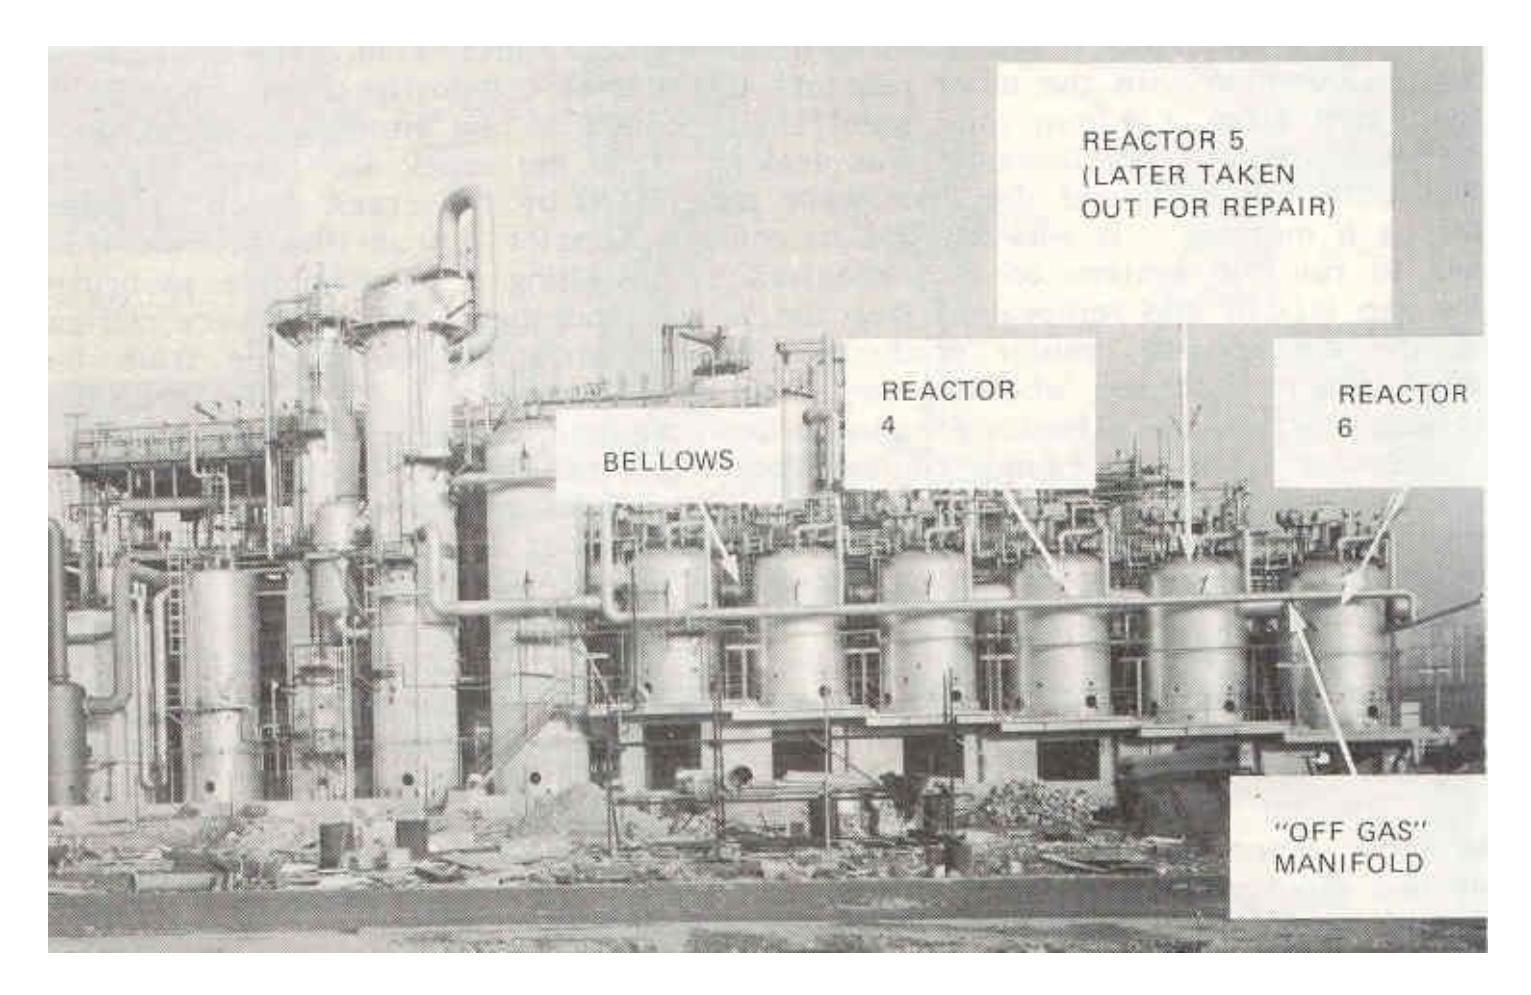
REACTOR CONFIGURATION

The process of oxidation is slow and it was decided to use six stirred reactors in series with the product from the first overflowing into the second and so on. To do this the reactors were mounted on a platform arranged in a series of steps each 0.355 m higher than the one following.

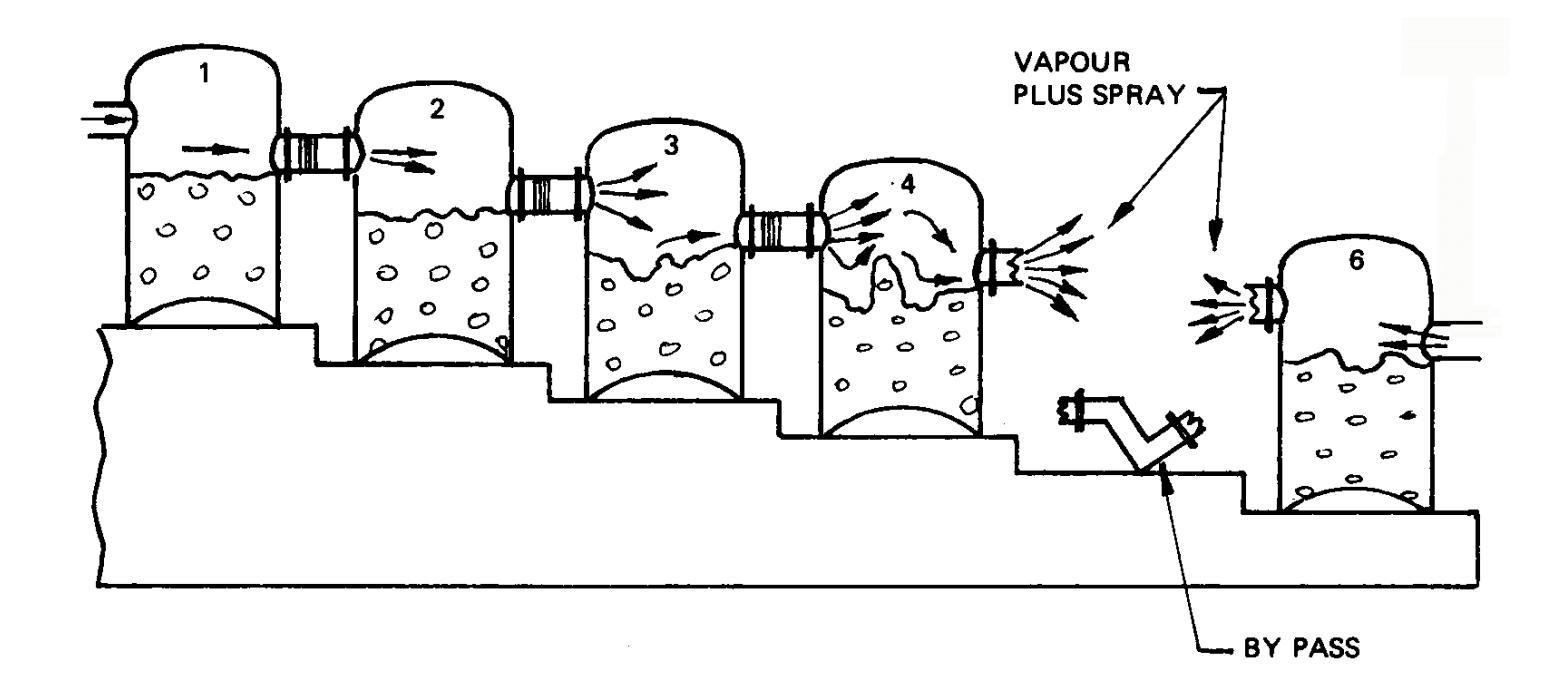
REACTOR CONFIGURATION

This schematic view indicates the basis of the incident.

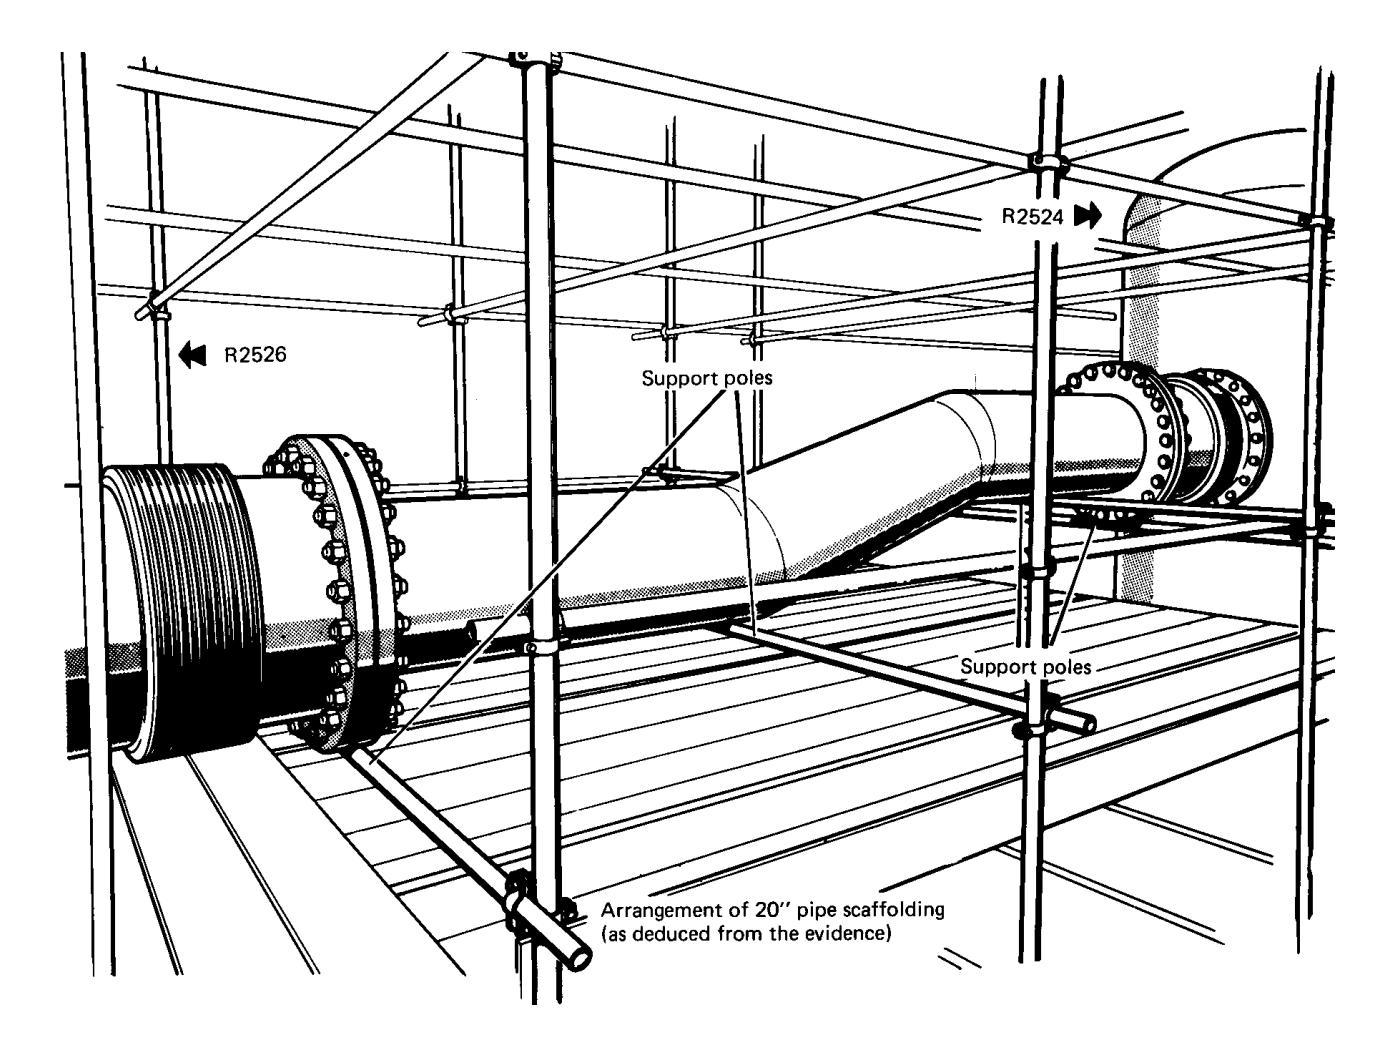
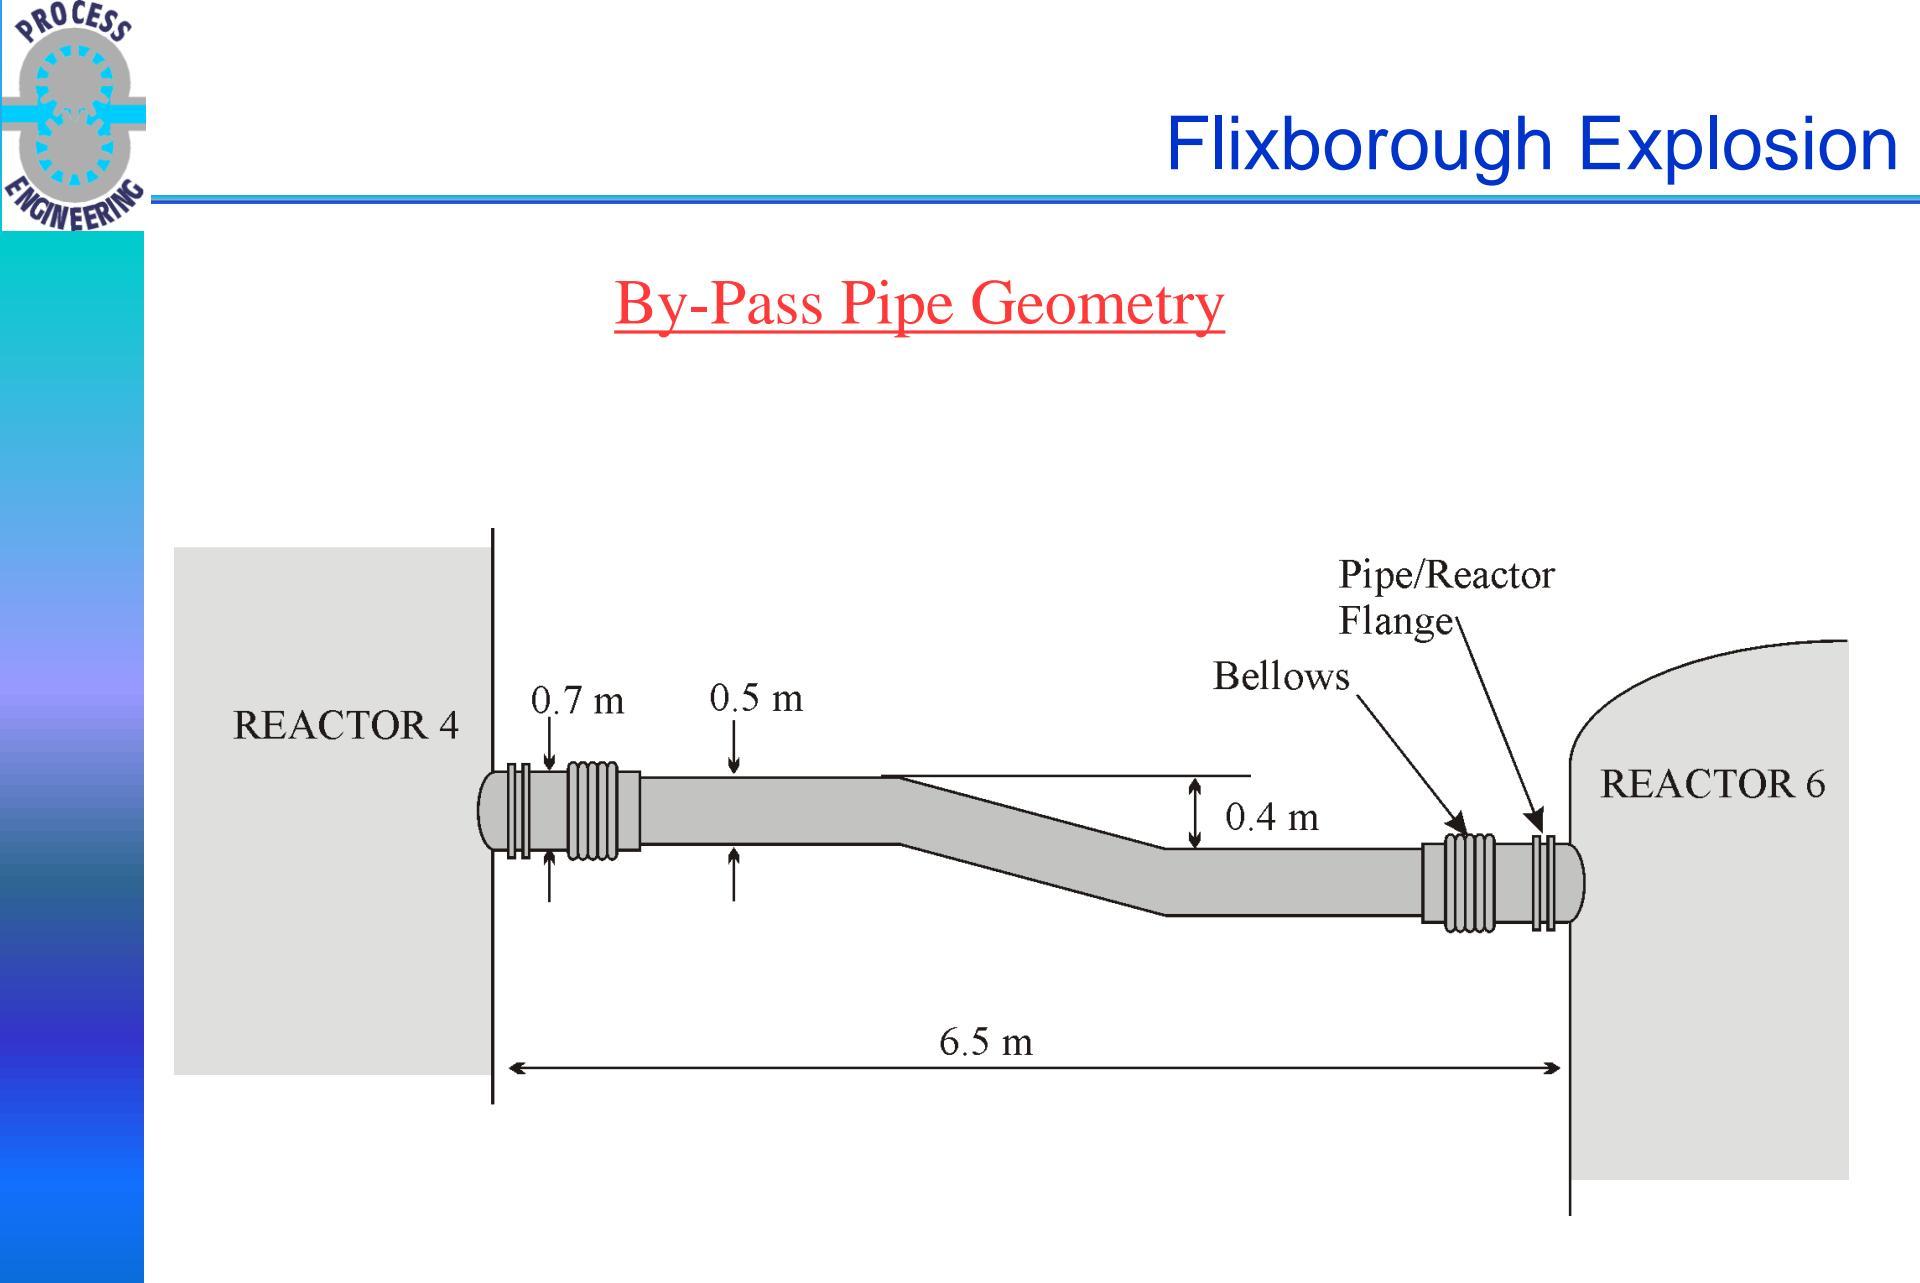
The pipe in question (i.e. the by-pass) formed a connection between two adjacent reactors over 6 metres apart. The reactor nozzles were vertically off-set for process flow considerations so the pipe had to have a dog-leg bend in it. The end of the pipe connecting to Reactor Number 4 was at a higher elevation (0.35 m) than the end connecting to Reactor Number 6.

The by-pass pipe itself had a bore of 0.5 m though the stub pipes emanating from both reactors were of a larger diameter of 0.7 m. There were two bellows in the stub pipes to permit axial expansion or contraction of the pipework.

By-Pass Pipe Geometry

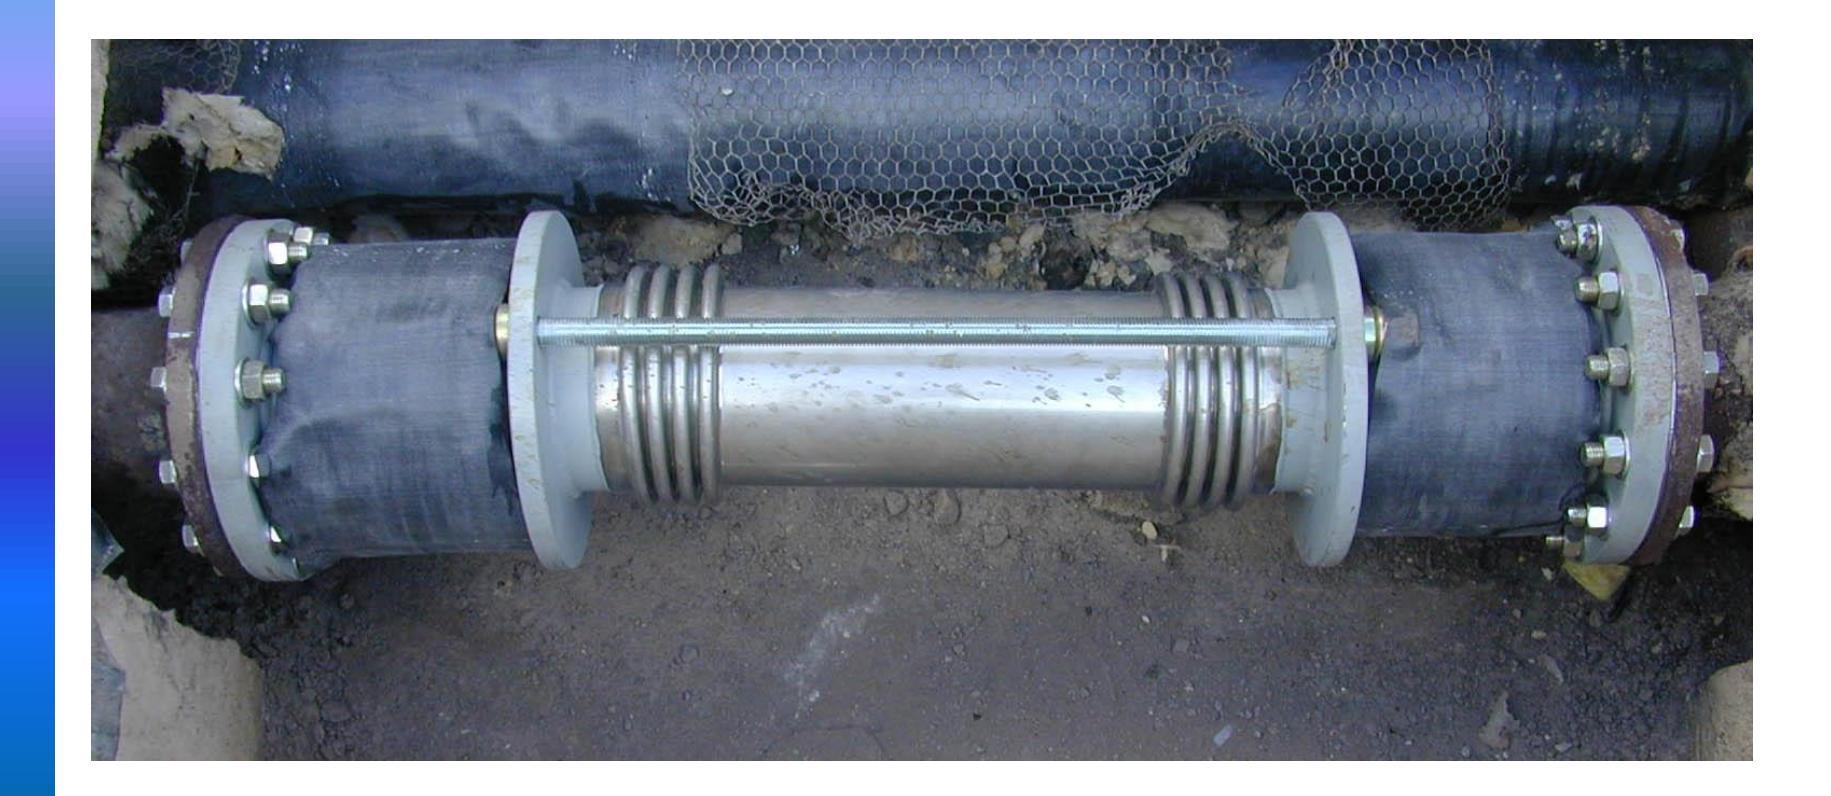
Bellows Joint Illustration

The picture shows a pipe section with a bellows at either end (i.e. the hoops)

Note: A bellows is a flexible pipe section that allows large axial deflection without generating high axial loads. Because of their construction a bellows cannot tolerate any significant non-axial loads.

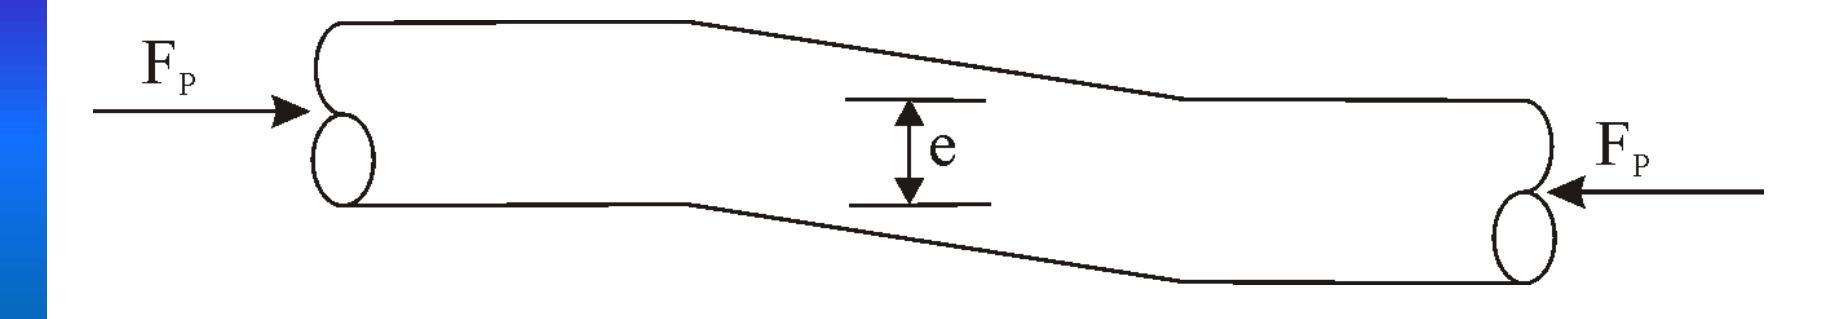
This was not included in stress calculations carried out on the by-pass and is of critical importance! This Bending Moment by far the larger of the two loads.

The dog-leg bend in the pipe means that a moment is developed due to the equal, opposite, parallel and non-collinear fluid pressure forces that the pipe is subject to at either end.

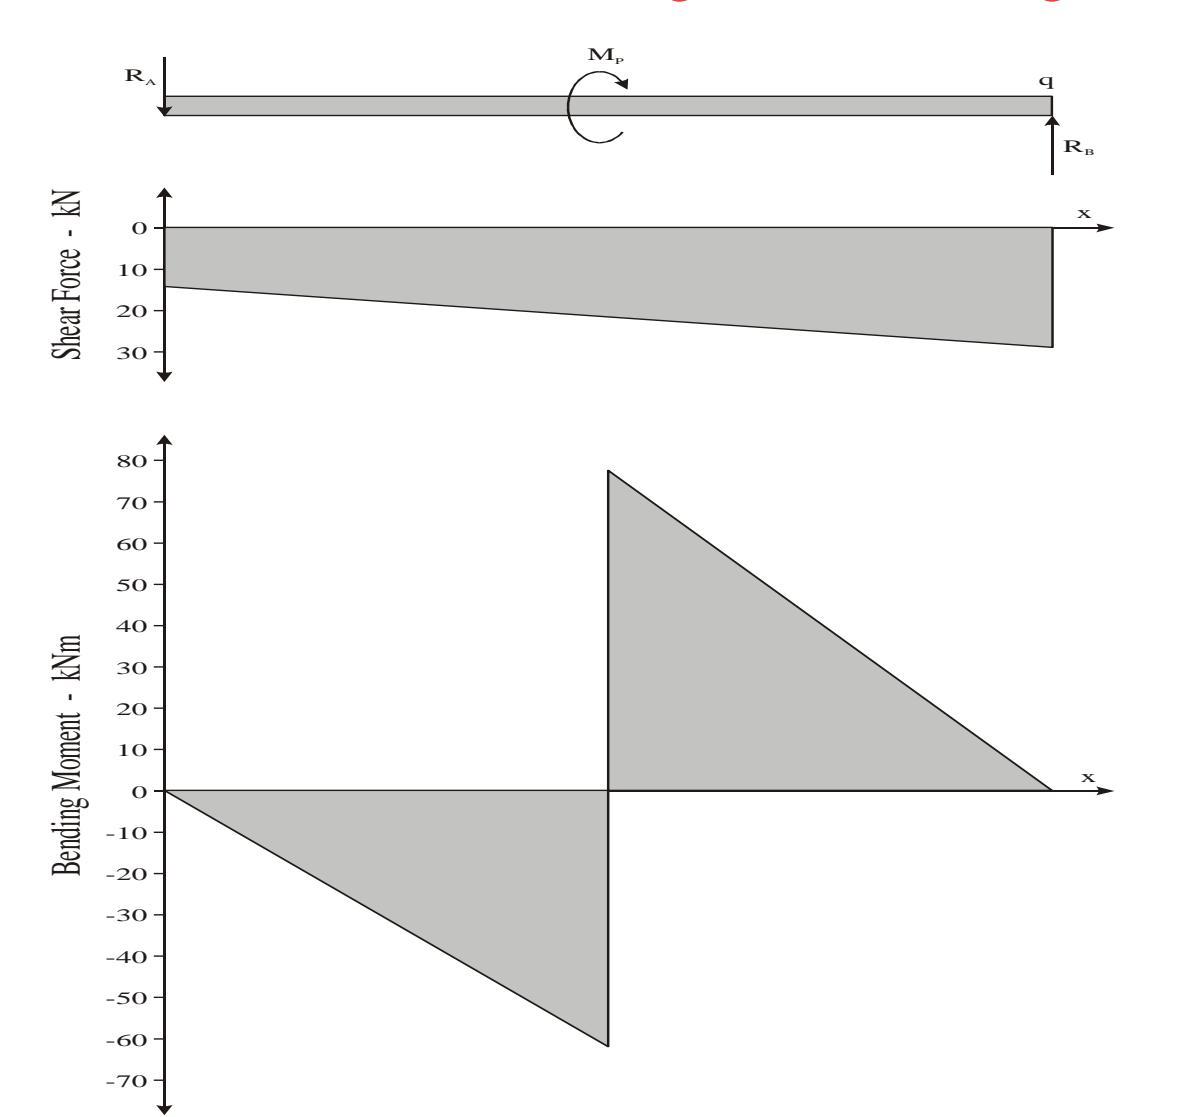
Shear Force & Bending Moment Diagram for Pipe

The above calculations indicate that the bellows at the lower end of the pipe (adjacent to Reactor Number 6) was exposed to a non-axial (in fact a perpendicular or transverse) force of almost 30 kN.

This would have been sufficient to rupture the bellows and allow large quantities of cyclohexane to leak out.

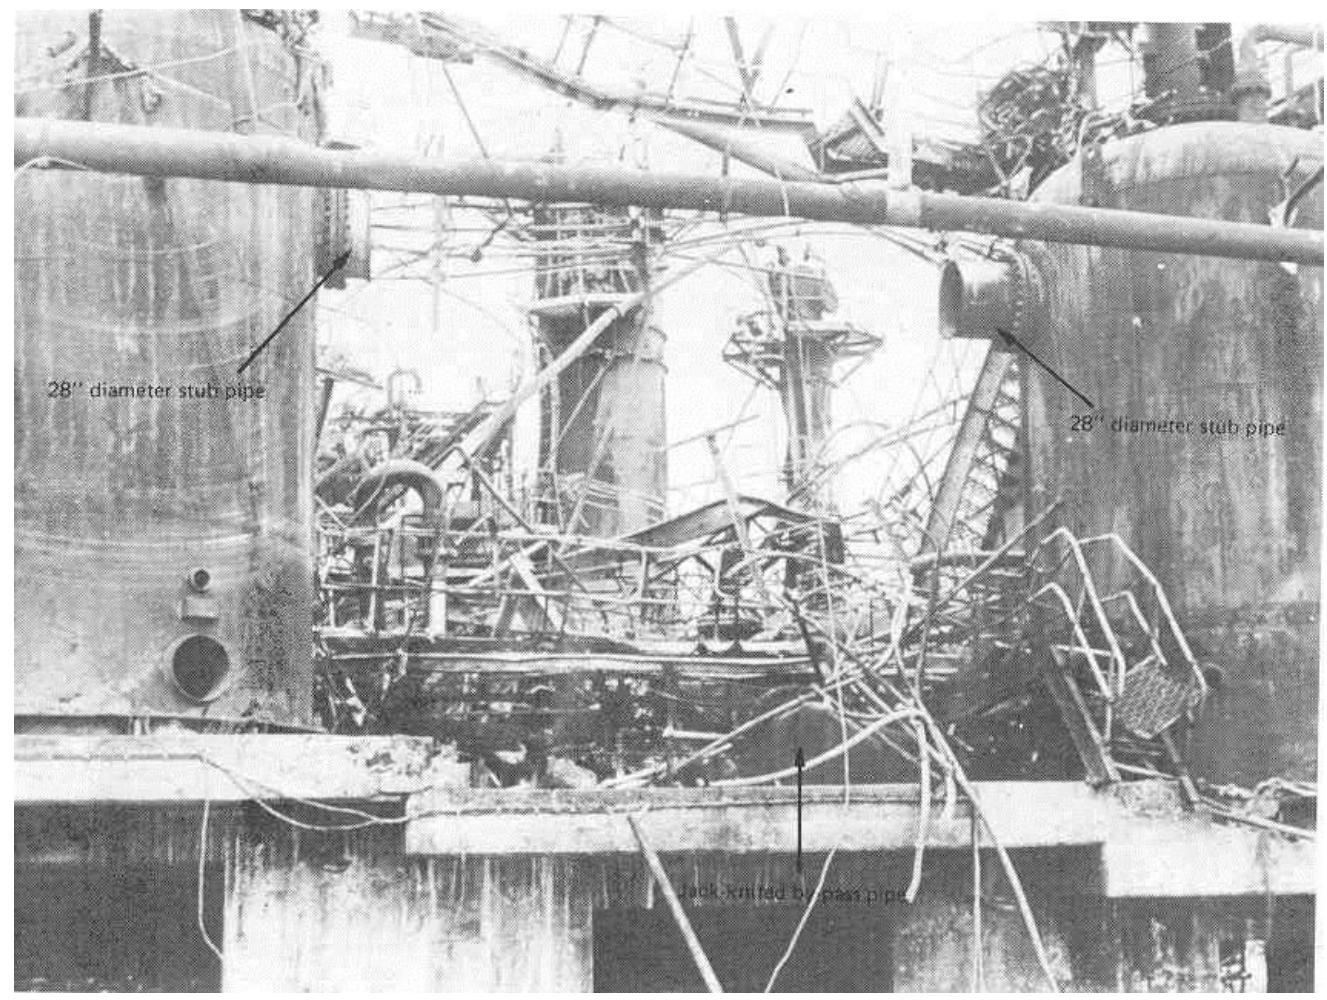
Picture shows reactors 4 and 6 after the accident.

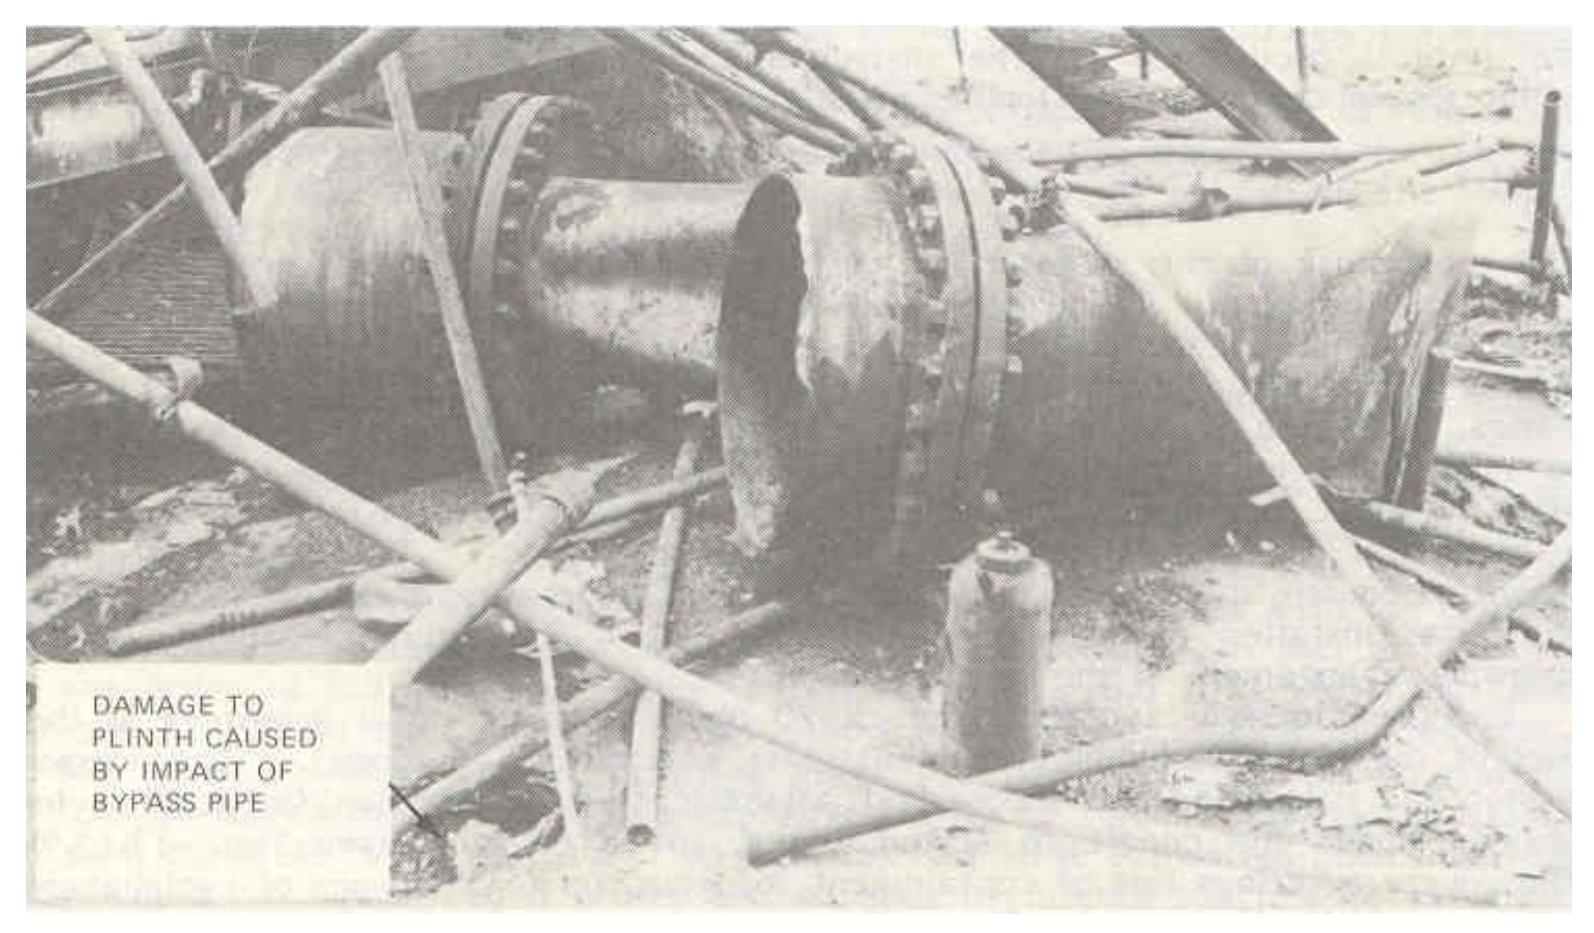
Picture shows the by-pass pipe after the accident
