Lessons learned *Methanol Tank fire*

June 26th 2017

*Raymond Bras
Unified Fire Brigade,
Rotterdam, Netherlands*

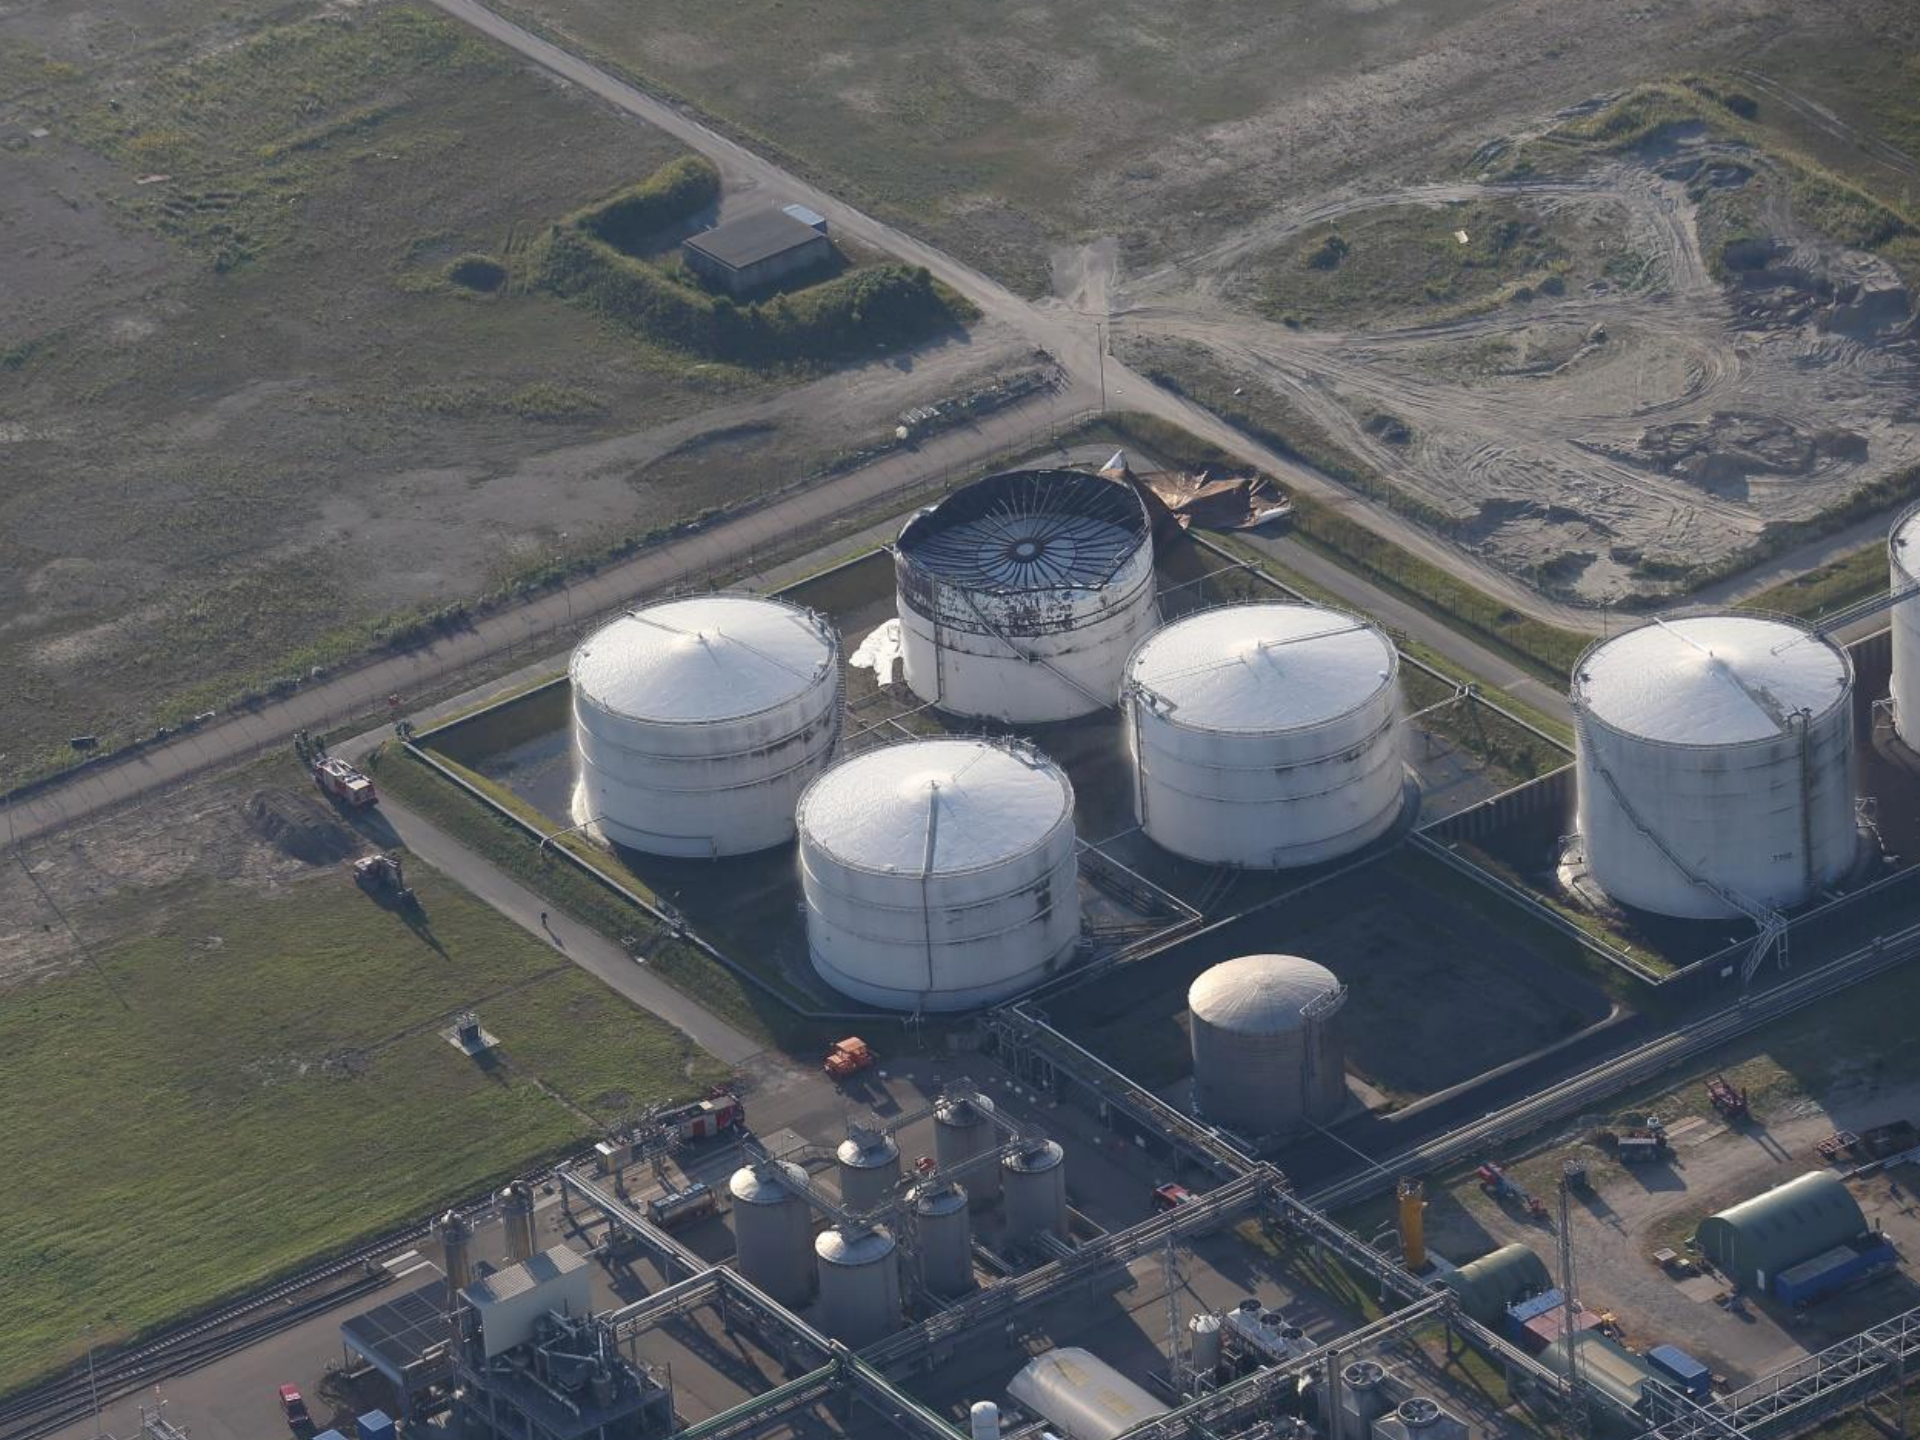
Exploring the area 2

- Other tanks seemed intact
- Cooling system is functioning correctly (other 3 tanks)
- Semi-subsurface system activated but there was foam leaking in the bund
- Drawings were available very quickly

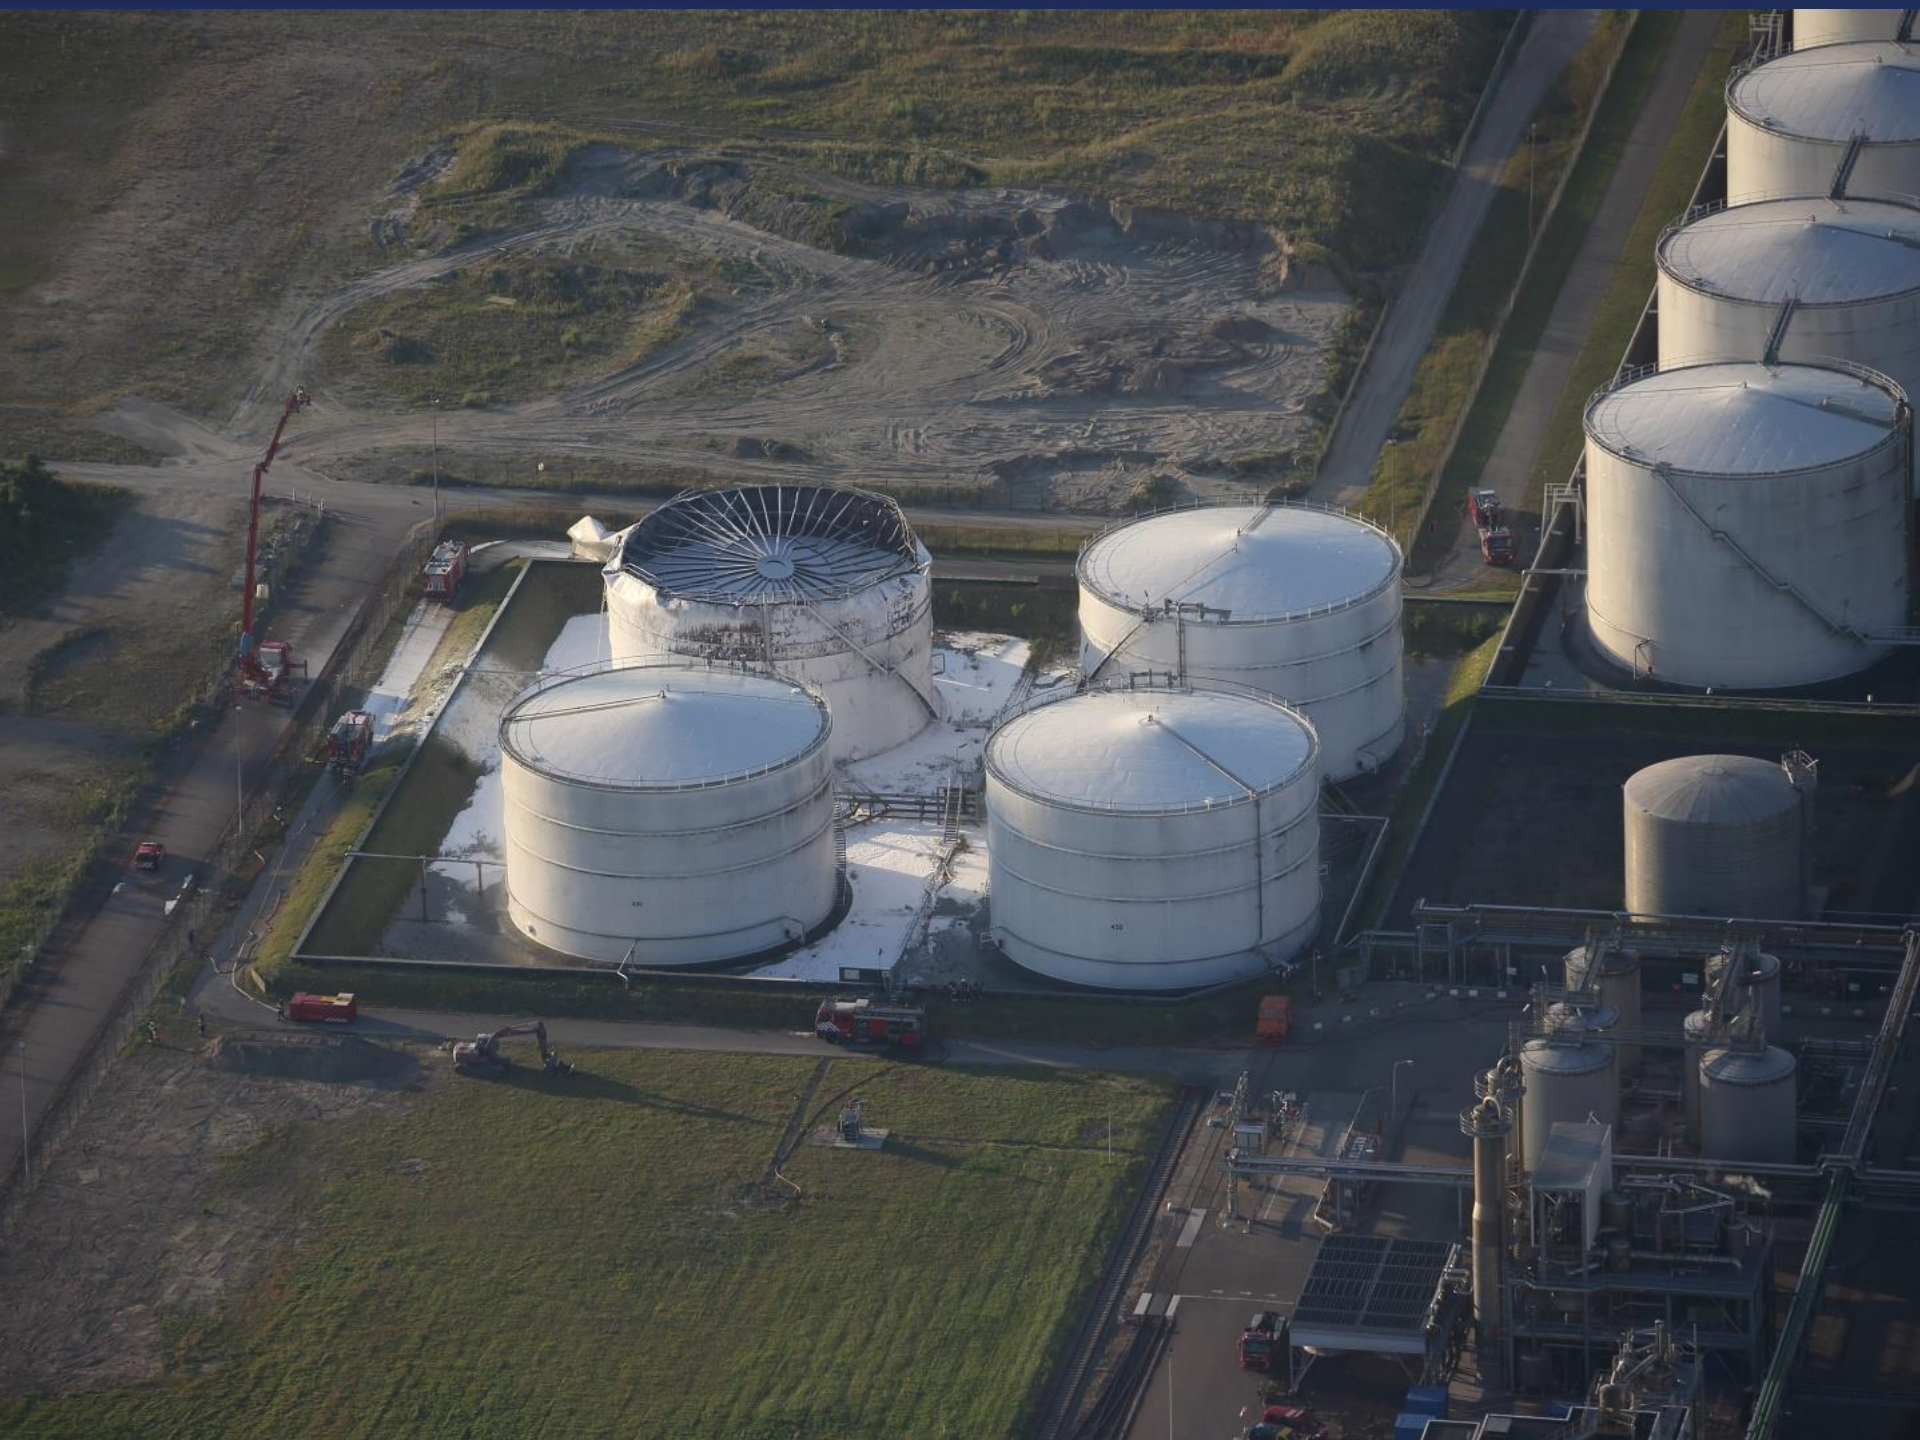
Tactics

1. Preventing escalation by using monitors of the industrial firetruck. First on the bund, later on the tank (roofmonitor and mobile in the bund)
2. Extinguishing the tankfire
3. Third truck on the opposite site (eyes and cooling capacity).
4. Aerial platform for our own helicopter view

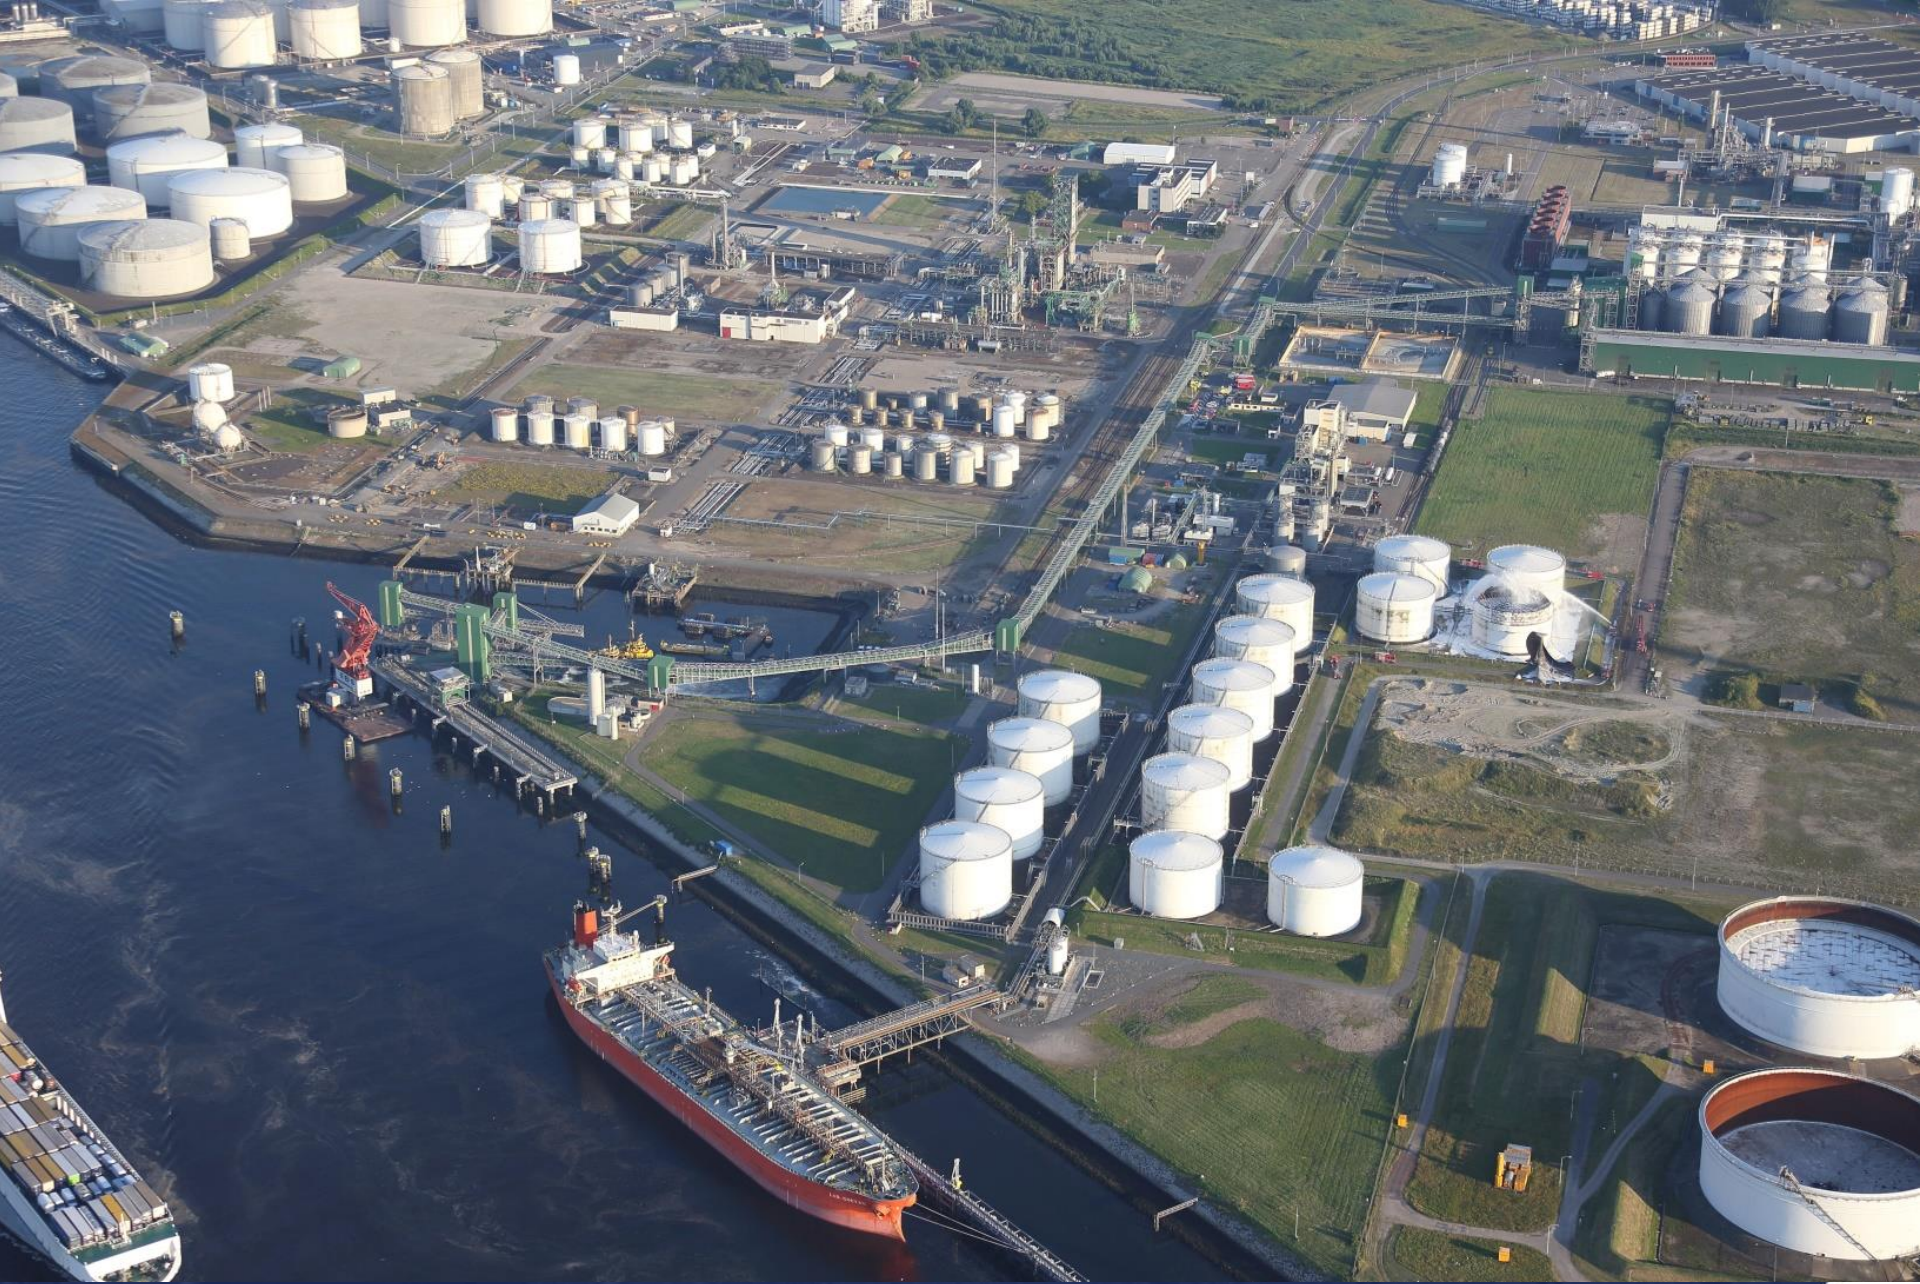
Semi-subsurface system

Worked fine, despite of the leakage.

- ATC 3/3%
- Ca. 14 m³
