BUND FIRE TESTING LITERATURE REVIEW

Note: The following information is based on the collective knowledge and experience of the LASTFIRE Group Members
(see www.lastfire.org.uk).

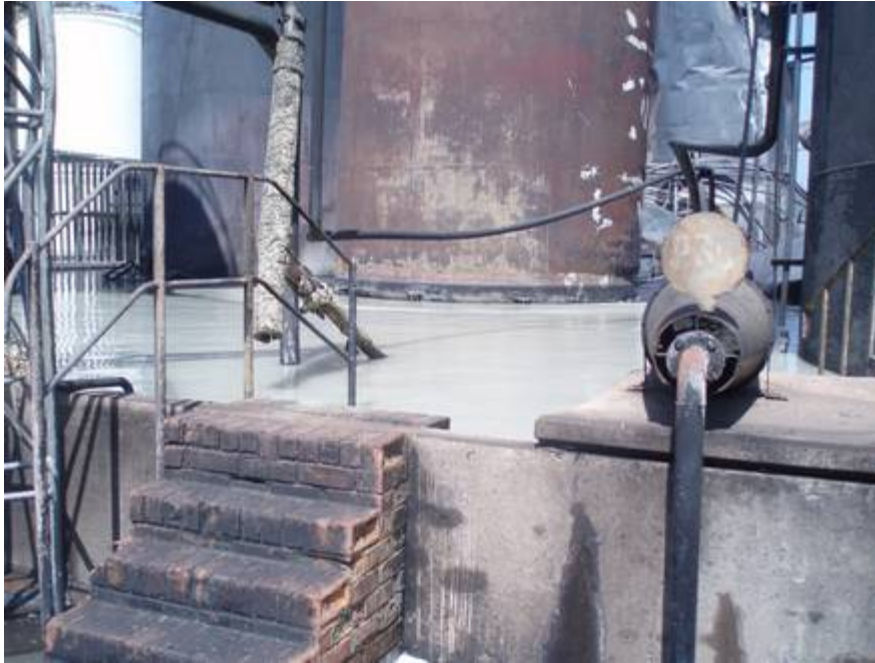
Figure 1. Example of a bund following a fire event with product and foam

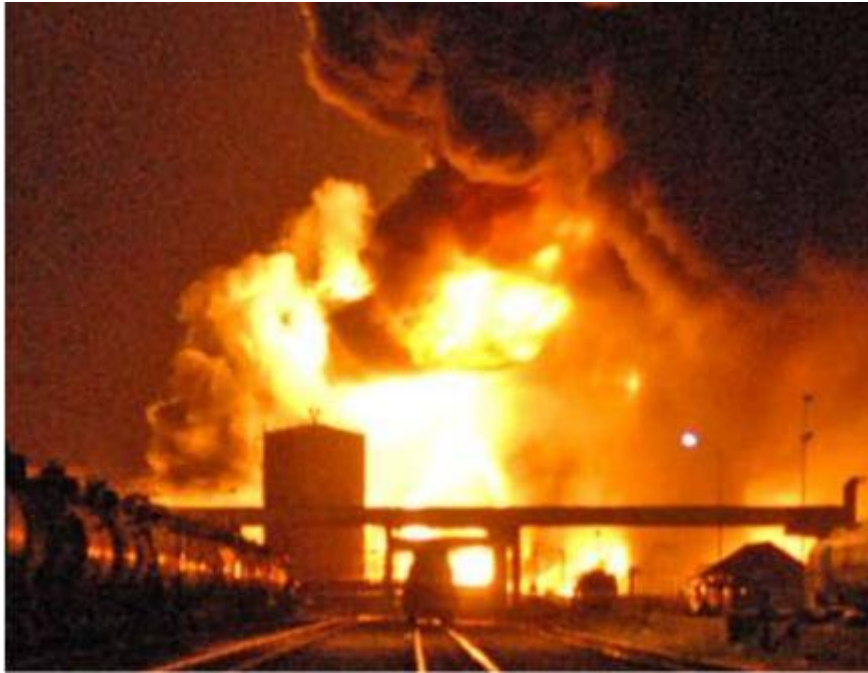
Figure 2. Large bund fire event example

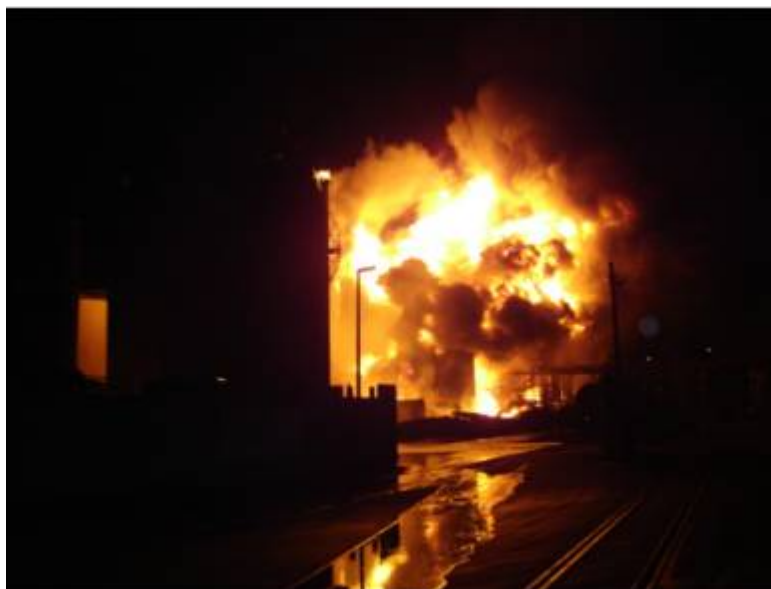
Figure 3. example of bund fire engulfing tanks situated in the bund
